Failure Analysis of Flood Collapse of the Tex Wash Bridge

Maryam Tabbakhha, Abolhassan Astaneh-Asl, Daniel Christian Setioso

University of California at Berkeley
Berkeley, California, USA
astaneh@berkeley.edu

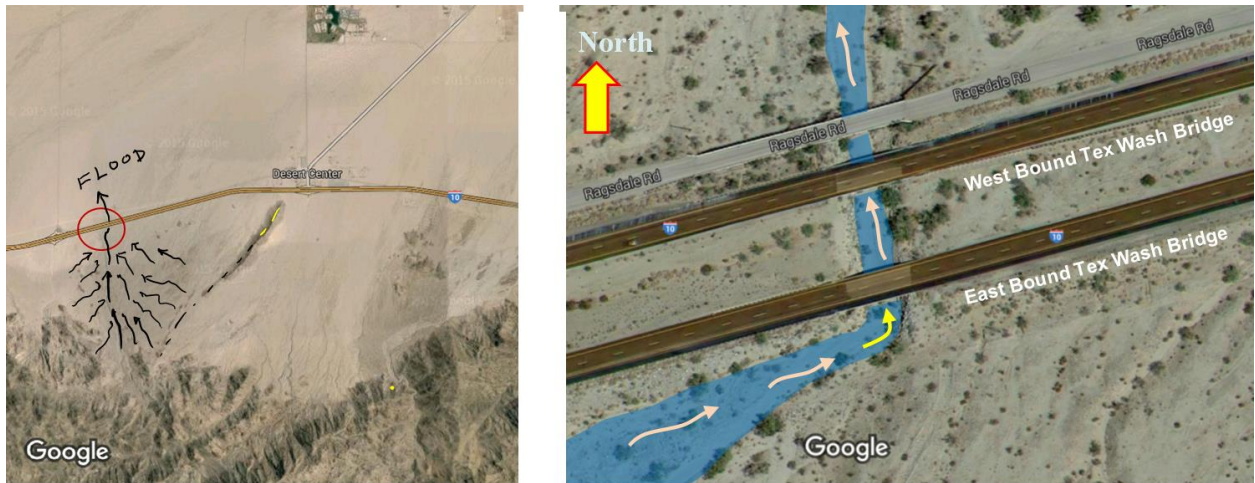
Fig. 3 shows areal views of the Tex Wash Bridge and direction of flash floods collected on its south side and rushed to pass under the bridge. As can be seen in Fig. 3, the channel that is directing the flood waters to the bridge is not straight. When the flood water flows north and arrives at the flat lands of Palm Desert, a relatively wide delta is formed. However, when the Tex Wash Bridge was designed and constructed in the 1960’s, the California Department of Transportation (also called Caltrans) narrowed the width of the delta from about 70 meters to only about 30 meters, presumably to save in the costs of construction. As a result, the flood waters, instead of flowing unhindered through the delta and being dispersed into the floor of the valley, ended up forced to make a 90-degree turn to the right and flow about 100 meters’ parallel to the Interstate Highway 10 and then make another 90-degree turn, this time to the left and pass under relatively short bridge. This turning of flood path without carefully studying the pressures that will be exerted on the embankment and bridge foundations and piers, was one of the four main design flaws that combined with other three, to be discussed later in this paper caused the collapse of the bridge.

Fig. 3: Areal Views of the Tex Wash Bridge prior to collapse and flow of flood waters.

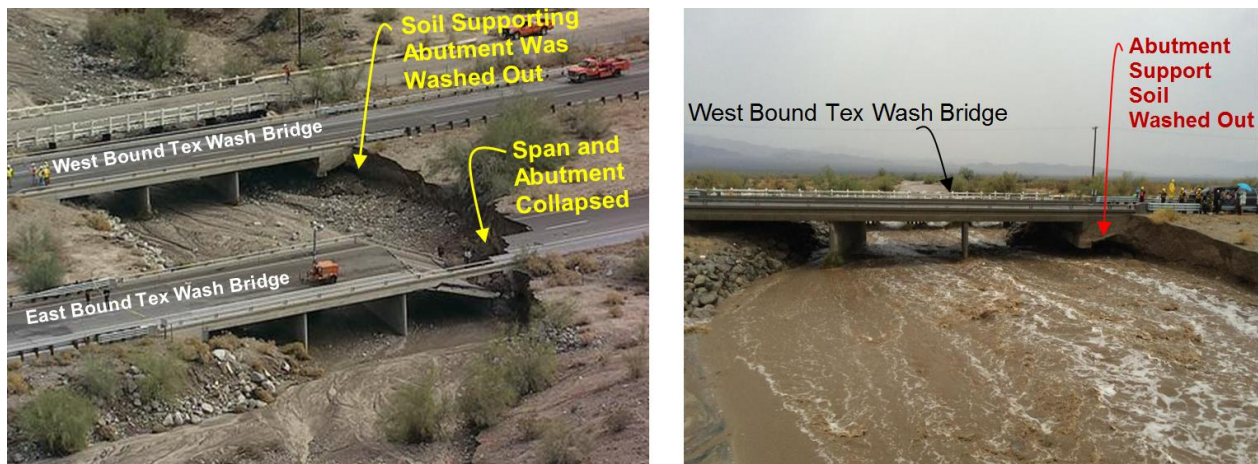
Fig. 4: Eastbound Tex Wash Bridge after Collapse.

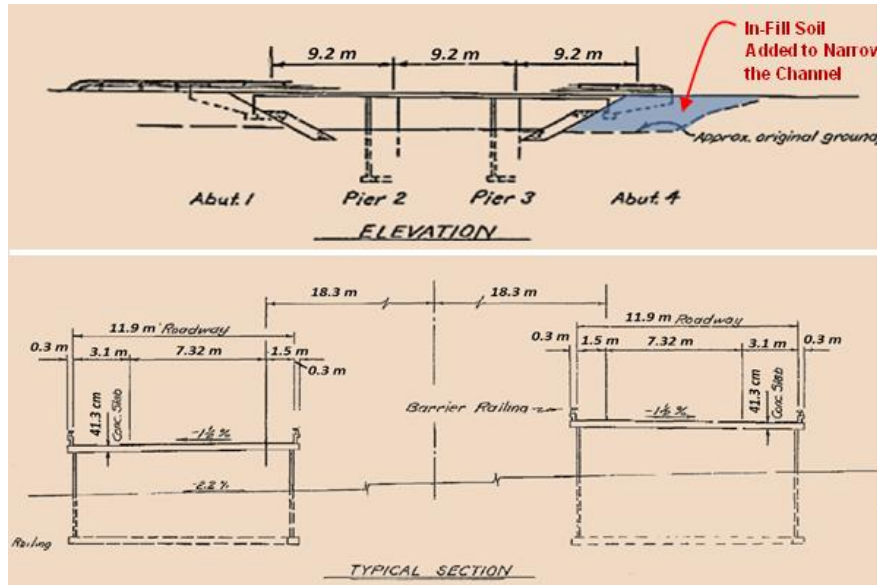
Tex Wash Bridge was constructed in 1967 on Interstate Highway 10 connecting Los Angeles to Phoenix in southwestern part of the United States. The Tex Wash Bridge is actually two parallel but separate and almost identical bridges, one carrying the eastbound traffic and the other carrying the west bound traffic. We will primarily focus on the east bound bridge that collapsed due the flood. The west bound bridge was also in the verge of collapse before the flood subsided. As Fig. 5 shows the bridge has a 41.3 cm thick reinforced concrete deck slab supported on two abutments and two wall piers. The abutments and wall piers are also reinforced concrete. Note that the right side abutment is sitting on infill soil. The flood pressure washed this soil out of under the abutment and left the abutment unsupported resulting in its collapse. Also note that the wall piers were safely supported on very deep foundations.

Fig. 5: Structure of the Tex Wash Bridge.

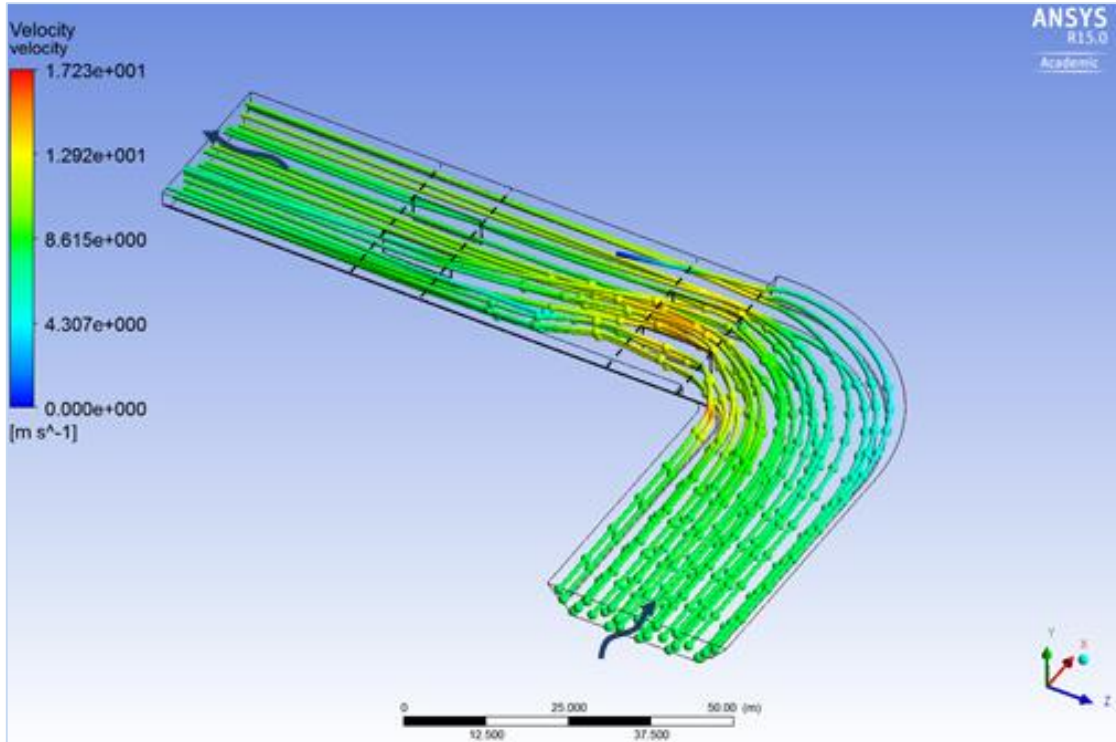
The contours of velocity and pressure during the flood are shown in Fig. 7 and Fig. 8 respectively. As shown in Fig. 7, the velocity of the flow within the east bound bridge piers is higher than the other parts. Moreover, as shown in Fig. 8, the level of pressure at the location of river turn is much higher than the other parts and that's where the relatively soft in-fill soil was located. The unit scales are shown in the left side of each figure. Fig. 9 and Fig. 10 show von Mises stresses in the bridge and displacement of embankment soil respectively.

Fig. 7: Velocity Profile of the Fluid Flow.

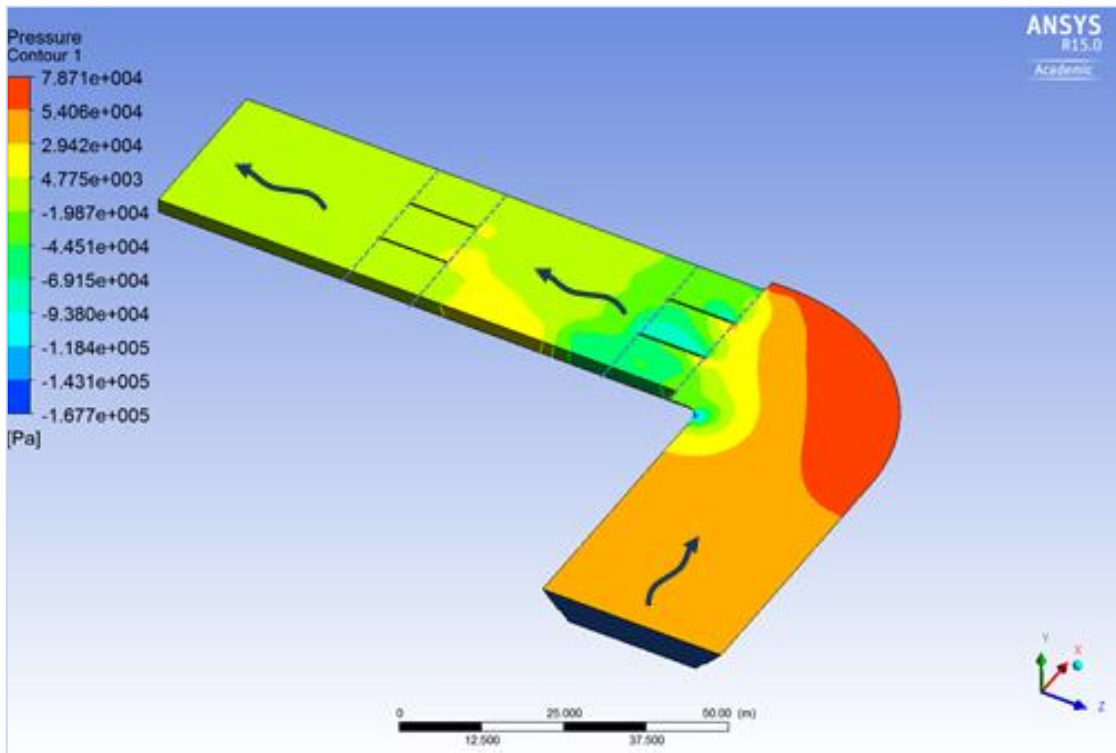
Fig. 8: Pressure Contour of the Fluid Flow.

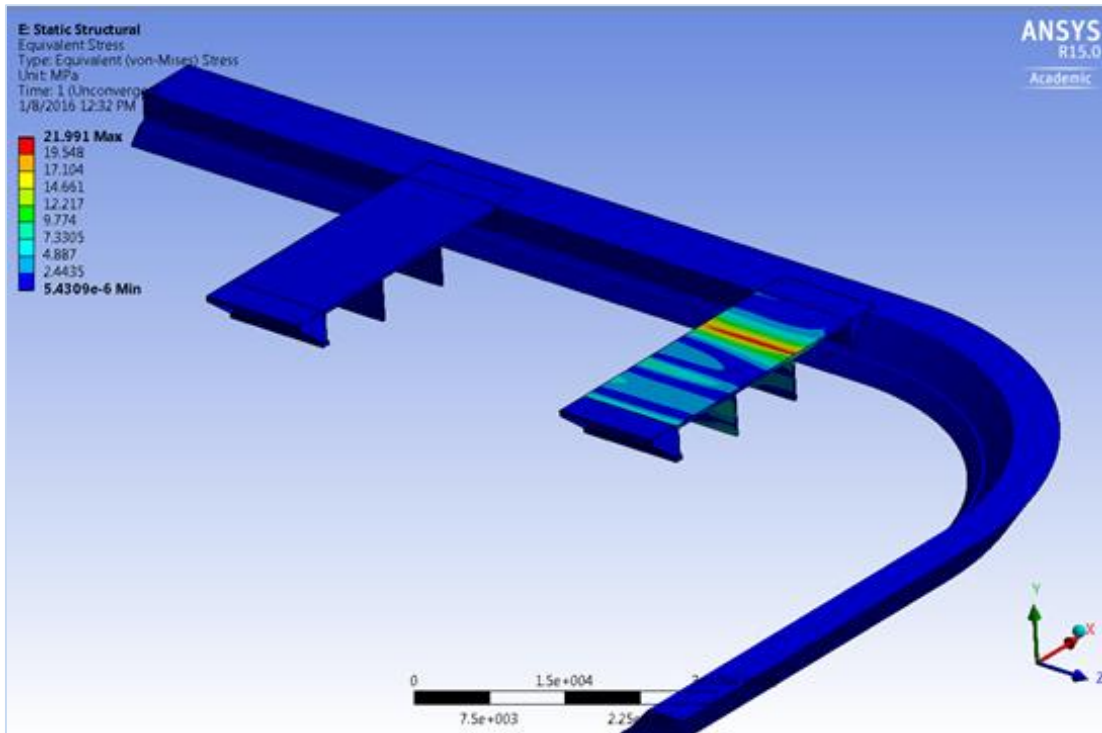
Fig. 9: Von-Mises Stresses of the Bridge Due to the Flood.

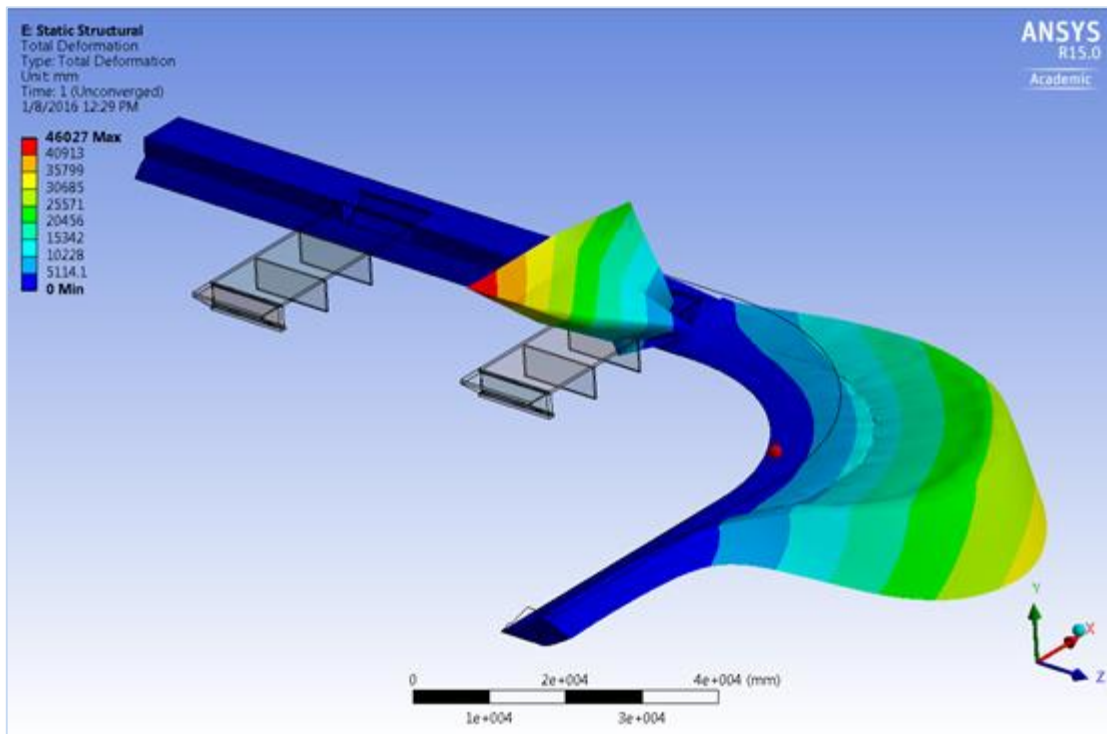
Fig. 10: Displacement of the Soil Due to the Flood.
