Investigation of a Significant Slide in the Embankment of an Old Dam

Sukhmander Singh¹

¹Santa Clara University
500 El Camino Real, Santa Clara, United States
ssingh@scu.edu

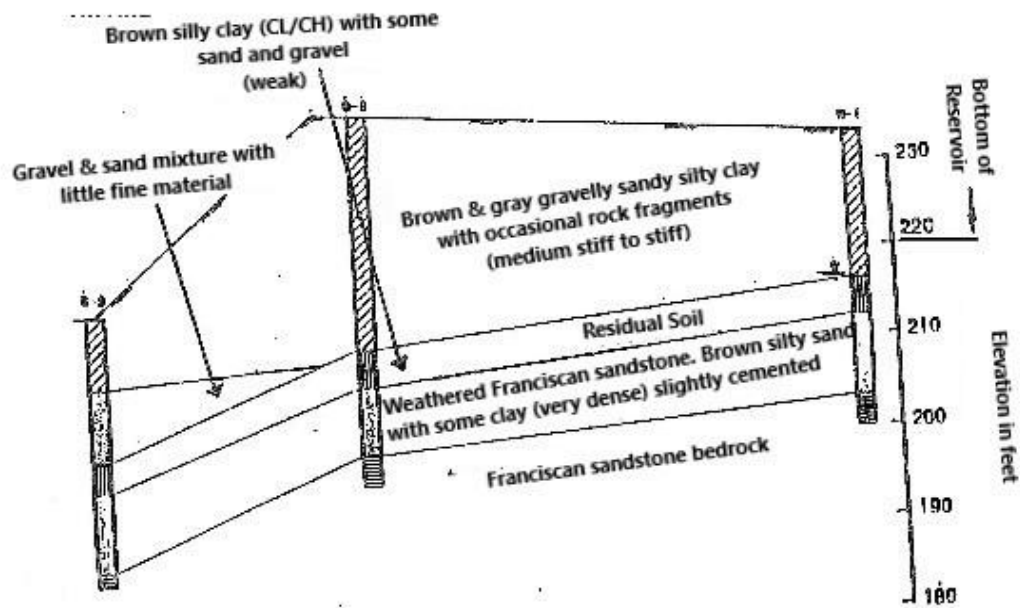
Fig. 2.

The four soil borings on the crest and two for geophysical study indicated brown and gray, sandy, silty, gravely clay (GC-C2) from a depth of 0 to 25 feet. Geologic report (Masliave, 1971) discovered the Franciscan bedrock formation of the dam site, most of the surface exposure are highly weathered. The dry density of the embankment material ranged from 98 to 115 per cubic foot and water content ranged from 14 to 25 percent. The strength parameters with respect to effective stresses were $\phi = 29^\circ$ to 32° and $c = 0$ to 100 pounds per square foot. Since the construction records were not available, it was not possible to establish the manner in which the fill was placed. The figure below shows the schematic soil profile.

SCHEMATIC SOIL PROFILE ALONG BORING LOCATIONS
 (See Fig. 1 for location of Borings)
 (Horizontal not to scale)

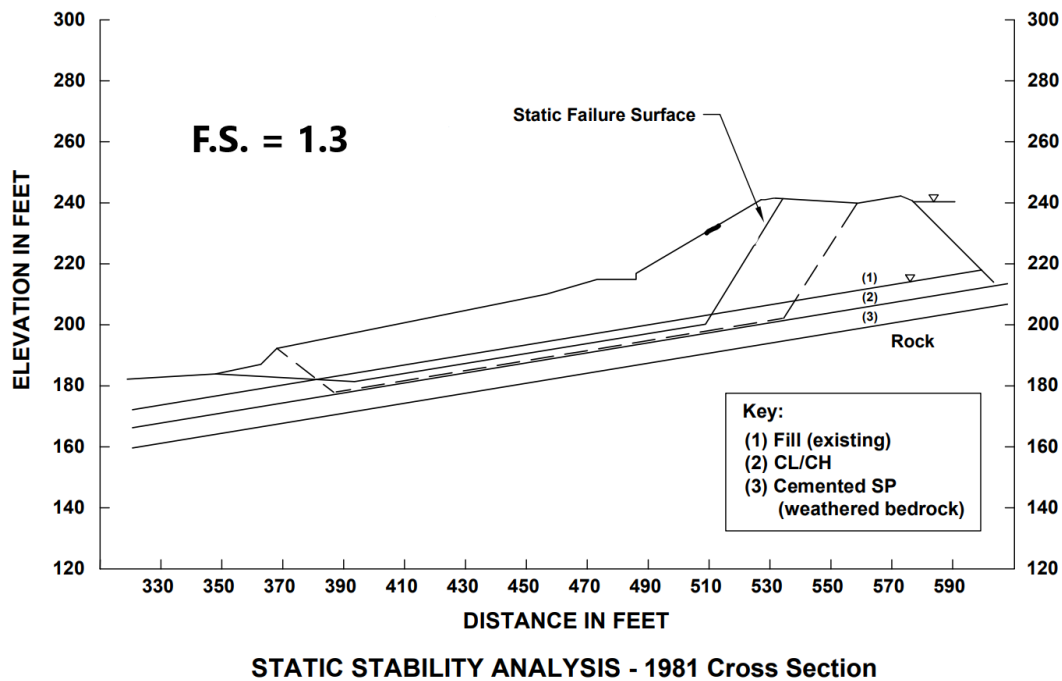
Fig. 3.

For static stability analysis of the slide area, the presence of a relatively weak, highly plastic clay layer (5 to 8 feet thick) overlying the bedrock was considered to be significant. Accordingly, the critical mode of failure was considered to be a planar block slide passing through the clay layer. A computer program developed U.C. Berkeley (Ceteslino and Duncan, 1980) that performs an automatic search for critical noncircular surfaces was used for stability analysis for the cross section shown in fig 3.

This cross-section was based upon documented topographic maps (Clyde 1930, Franklin and Dayton, 1972) and groundwater elevations noted in 1930. The factor of safety came out to be much higher than unity which contradicted to the fact that the slide was slowly moving. A close examination of the strength parameters was warranted. Since it was difficult to retrieve high quality, undisturbed samples of a thin, highly plastic clay layer by boring and sampling, cone penetration testing was performed at six different locations. Figure 4 shows the cross-section showing CPT test results.

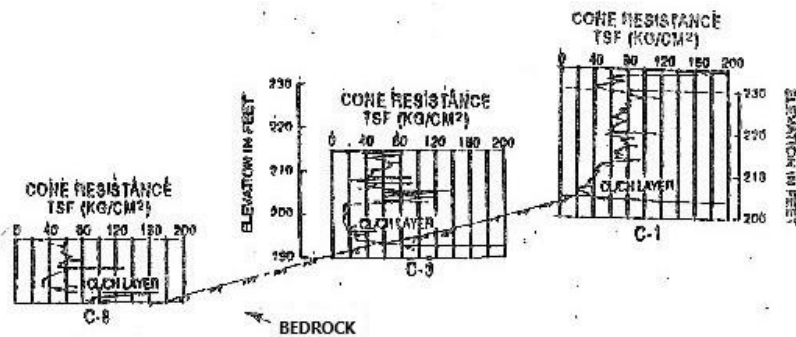
**Fig 4 SECTION THRU CONE-PENETROMETER TEST HOLES
(REFER TO Fig. 1 FOR LOCATION OF CPT HOLES)**

The cone resistance revealed significant drop in the highly plastic layer. This significant drop was just above the bedrock and below the embankment material (fig. 4). The most critical observation was that the strength indicated by cone resistance was much lower than the strength value obtained by laboratory testing of samples. It was argued that due to the sloping topography and the long-term loading on the clay layer might have resulted in its residual strength value. Accordingly a laboratory testing program to evaluate residual strength of the clay was undertaken. A number of tests under drained direct shear conditions with reversal of strain direction to induce residual strength performed on the clay samples. A residual angle of friction came out to be 16°, which was much less than the 30° used in the earlier stability analysis. The cone test results were also helpful to more accurately indicate the thickness as well as the continuity of the clay layer. Thereby reinforcing the idea that it was this clay layer which provided the original slip surface of sliding.

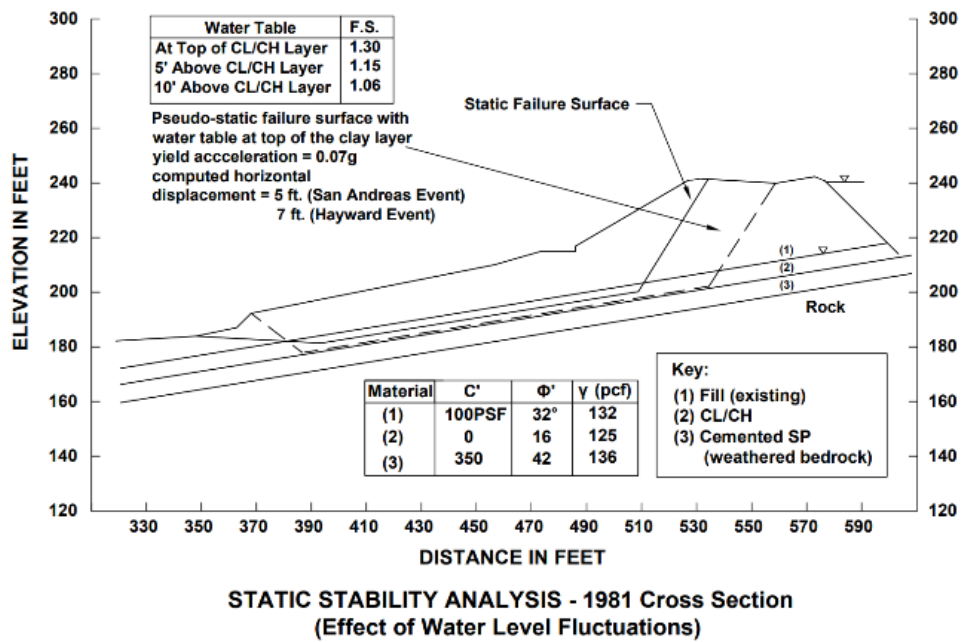
Fig. 5.

The safety factor came out to about unity which matched with the sliding that has been occurring over the years. In order to resolve why the slide had been moving during the raining season, additional analyses were carried out to evaluate the effect of water table fluctuations. Attention to details in the development of the subsurface profile and the application of the in-situ cone testing technique were helpful in defining the failure surface and in arriving at the correct soil strength parameters. The foregoing results made it clear that the most effective means of improving the stability of the embankment would be to remove as much of the weak clay layer as is possible and replace by a free draining material. Remedied measure to improve the stability of the dam involved removing as much of the weak clay layer as possible, which was undertaken after emptying the reservoir and by replacing the removed clay layer with free draining granular material.
