Critical Rainfall and Slope Hazards in Central Taiwan Mountain

Sung-Chi Hsu¹, Qi-Zhi Liao², Yi-Chun Yeh³

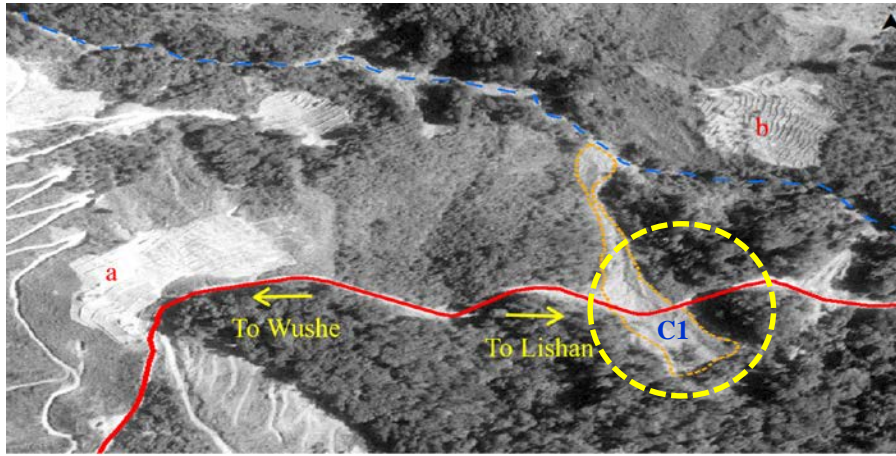
The collapsed areas and road locations were found based on the orthophotos. The collapsed areas and road locations were drawn after overlapping the aerial photographs of the past years. However, the orthophoto images can tell the condition of the bare zone in the year. Still, it is hard to accurately determine which typhoon or torrential rain event caused the landslide. Figure 2 is an orthophoto of 49K taken in 1980 [4]. The red line is the road now, the blue dotted line is the valley on the downhill, the east (to the right) is the direction to Lishan, and the west is the direction to Wushe. The yellow dotted area is the damaged area. According to the aerial photos, areas a and b are likely to be farming phenomena, and there are also roads in and out of farming. From the aerial photo of Figure 3 on September 6, 2009 [2], the place has experienced several Typhoons, such as Taozhi, Minduli, Begonia, and Masha, and heavy rainfalls. The original damaged area of C1, shown in Figures 2 and 3, has expanded the collapsed scope of the upper and lower slope due to the above events. The newly collapsed area C2 could be caused by the erosion of the valley creek (the blue dotted line in Figure 2).

1980/5/18Ranger — 1980/5/18Road — 1980/5/18River — —
 Figure 2 The road and bare area caused by slide from the Aerial photo taken on May 18, 1980 [4]

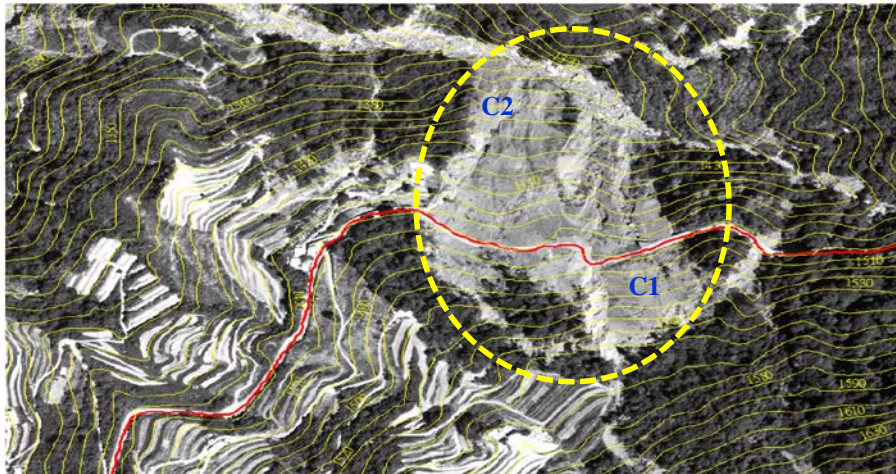
Figure 3 The topographic map, extended bare areas and road on September 6, 2009 [4]

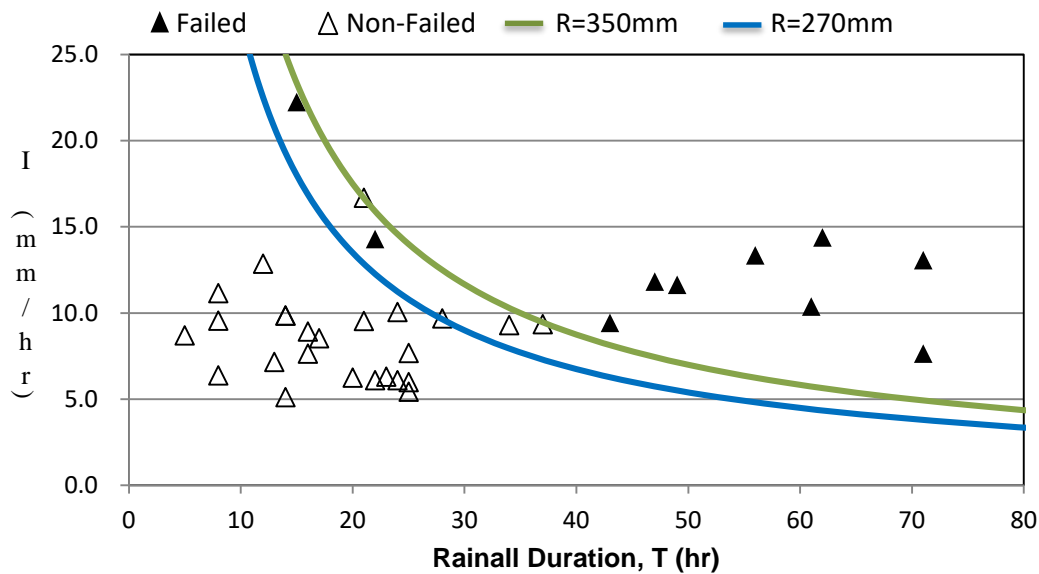
The assessment of the critical rainfall is found based on the previous information of slope hazards. The accumulated rainfall from 1996 to 2013 are collected, synthesized and analyzed. The judgement of failure or no failure development of each rainfall incident is based on the government or consulting companies' aerial photos and related reports. The average hourly rainfall (I) and rainfall duration (T) for each rainfall event is estimated. Many people used the rainfall driving indicator (RTI) to identify the critical rainfall boundary. The R is the accumulated rainfall and is calculated as T times I, i.e., $R=TI$. The crucial boundary for the debris flow occurrence is R equals 250 mm in Taiwan. Therefore, the T is plotted against I with $R=270$ and 350 mm boundary lines shown in Figure 4. As shown in Figure 4, the R for all the failed events is greater than

270 mm. About 80% of the failed cases have R greater than 350 mm. Thus, the critical rainfall boundary for the road at 49K is suggested as $R=270$ mm. When the accumulated rainfall, R, exceeds 270mm, the slope in 49K may experience slope hazard. If the average rainfall (I) exceeds 7.5mm and rainfall duration (T) above 40 hours, slope hazards may also happen.

Figure 4 Average rainfall versus rainfall duration for cases at 49K.

The failed areas and rainfall data for 49K of Nantou 89th County Road are synthesized in this research. Based on this research, the critical rainfall boundary for the road at 49K is obtained as $R=270$ mm. If the average rainfall (I) exceeds 7.5mm and rainfall duration (T) above 40 hours, slope hazards may also happen. It is recommended to take the accumulated rainfall of 270mm as an indicator for a future evacuation.
