# Evaluation of the Seismic Behaviour of a Building for Residential Use Based on a Typical Soil and Implementing the Ecuadorian NEC-SE-DS Standard

**Abstract** - The present work allows evaluating the behaviour of a building in the city of Guayaquil built on a soft soil type E, considering the seismic performance based on the last earthquake that hit Ecuador and left irreparable damages. For this reason, the structure was modelled for further analysis using structural analysis software (ETABS) to evaluate and compare the values collected from the measurement in the accelerograph of Guayaquil and Manta, and thus have a reference and knowledge regarding the damage, displacements and deformations presented.

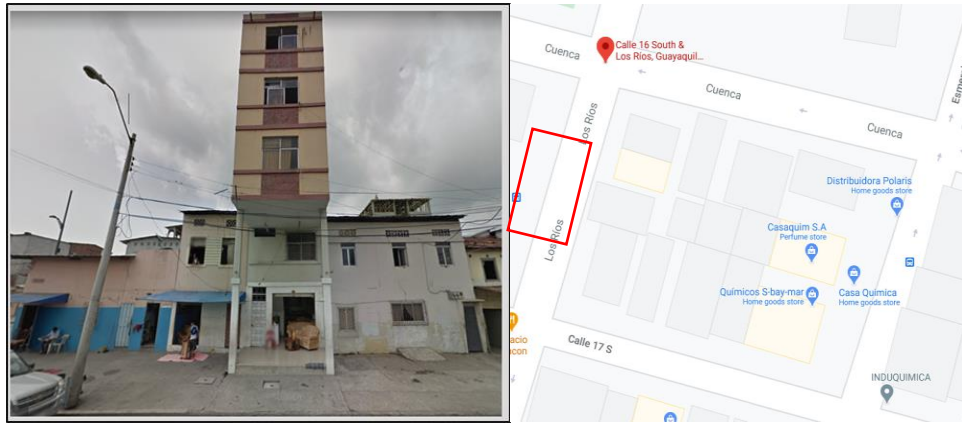
Figure 3. Front and plan view of the building

All the vulnerability indexes are compared with respect to the limit that defines their seismic vulnerability (except for the methodology of Lang and Singh in which the maximum index is presented), all the methodologies indicate that the case study building presents a high seismic vulnerability due to its structural configuration and visible lack of seismic solicitations.

After carrying out the analysis of the current structure, it was observed that it presents slenderness in the elements, which causes a low structural rigidity, especially in the lower levels, which instigates very high periods of vibration to the structure, causing a structure susceptible to severe damage (Fissures, tearing, non-habitability or collapse) in the face of future seismic events.

The existing structure presents a relationship of structural elements without engineering criteria, this due to the informality in its construction, this point is demonstrated by observing columns of lower floors with smaller dimensions than the upper floors, causing the soft floor effect, since the resistance in the lower floors is less than 70% of the resistance of the immediately superior floor in the first two levels.

The effects of the constructive irregularity of the structure cause mezzanine drifts to be much greater than the maximum permissible by the Ecuadorian Construction Standard (2%) in the first two floors.

The new structure proposed when performing the static, pseudo-dynamic and dynamic time-history analyses, the structure, and its redesigned elements are suitable and meet the requirements of the Ecuadorian construction regulations in contrast to the current structure that has structural elements Without criteria, this being a structure that puts its occupants at risk.

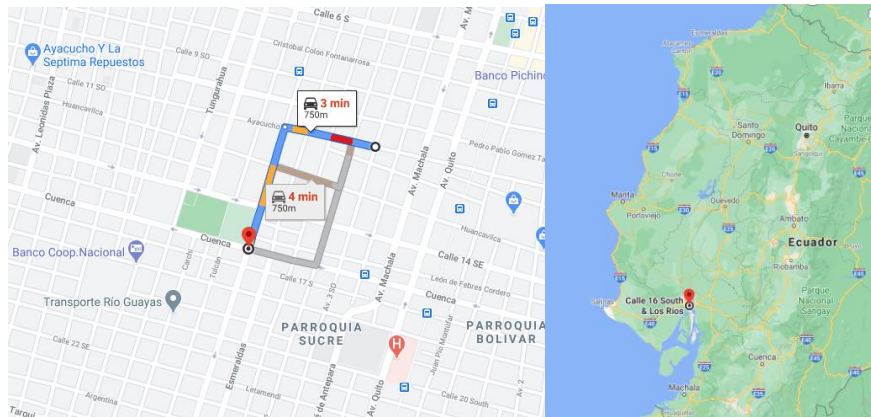
Figure 4 Collapse building in Guayaquil, during 2016 Ecuador earthquake

Furthermore, during the 2016 Ecuador Earthquake, a very irregular building, located in the corner of García Moreno and Ayacucho streets in Guayaquil (Figure 4, collapsed). Fortunately, neither casualties nor harm to people were reported. The four RVS methodologies were applied to this building and reported in Table 3. It is not surprising that the building presented a very high seismic vulnerability, similar to the case study building.

What is more interesting about this case is that the case study building is located just a few blocks from the collapse building, as illustrated in Figure 4. The collapse building presented more irregularities than that of the case study building. However, some of the structural deficiencies as well as the soil conditions are shared. Therefore, conducting a more detailed analysis through a numerical model can help us to understand what conditions can trigger the collapse of the case study building or to determine that earthquake loading will be detrimental for this residential building.
