Proceedings of the 9th World Congress on Civil, Structural, and Environmental Engineering (CSEE 2024)

Stability Analysis of Surface and Subsurface Geological Hazards Using Numerical Approach in Hydropower Project of India- a Case Study

Parbati Hydroelectric Project-II, Nagwain, Himachal Pradesh, India mainakghosh@nhpc.nic.in; nirmalsingh@nhpc.nic.in

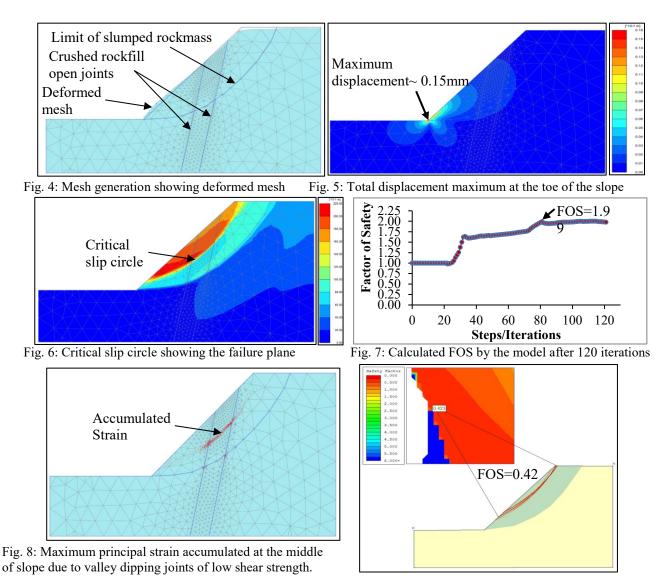
Fig. 9: Critical slip circle and calculated FOS determined by Slide

Comparison of FoS values determined from FEM and LEM shows that both the models indicate development of critical slip circle of failure at a depth of 10-15m as shown in Fig. 6 and Fig. 9. Calculated FoS values from FEM is 1.99 as shown in Fig. 7 which indicates fairly stable condition. However, the same slope stability analysis in LEM calculates FoS values of 0.423 which indicates unstable slope condition. This difference in values can be interpreted by the fact that, FEM consider elastic parameters such as Young's modulus and Poisson's ratio in their material properties and lay more emphasis on the geometry of the slope whereas LEM considers uniaxial compressive strength of the rock, disturbance factors like blasting damage during slope excavation and also m_i and s parameters of Hoek-Brown. Thus based on the experience of sliding and slope failure experienced during excavation of powerhouse backslope, LEM appears to give a more realistic assessment of the instability of the powerhouse backslope than FEM.

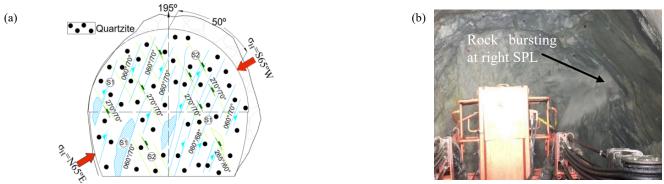
Fig. 12: (a) Geological face log of HRT showing principal stress directions (b) Rock bursting in right springline (SPL) area of HRT

Based on the world stress map (2016), it is found that in the study area, the direction of in-situ vertical and horizontal stresses (S65°W) are oriented subparallel to the major joint set (270°/70°) and at high angle (50°) with the tunnel alignment (N195°) as shown in Fig. 12(a). According to Laubscher (1990), both the above conditions are conducive for rock bursting which has been experienced frequently during tunnel excavation in massive and brittle quartzite under a high superincumbent cover ranging from 750m to 1600m. On the basis of rock bursting events experienced during excavation in quartzite rockmass in head race tunnel (HRT) of Parbati hydroelectric project-II as shown in Fig. 12 (b), back analysis of magnitude of in-situ stresses in rock bursting zones was carried out using FEM (Phase 2, v.8.0) to determine the role of strength, elastic properties of the rockmass and field stress ratio in causing rock bursting. Principal stress, deformation values and strength factor at two different stress ratios corresponding to minimum and maximum overburden cover of 750m and 1600m respectively were determined using numerical method.

- (f) The reason for frequent rock bursting during tunnelling may be accounted due to unfavourable orientation of tunnel and major discontinuities intersecting the encountered rockmass w.r.t. the direction of principal stress. Stress analysis through numerical modelling shows that both yielding and deformation increase with decrease in field stress ratio i.e. with increase in overburden depth. Drilling of stress relief holes, installation of untensioned rock anchors at close spacing alongwith steel fibre reinforced shotcrete at crown and springline area of the tunnel were the remedial measures applied to tackle rock bursting.
