# **In-situ Repair of Stator Core of Hydro-generator - Establishing the Process**

Similar situation was faced when fault occurred on a 180MW hydro-generator. The repairs were carried out without core disassembly and replacement. Finally, a repair process was formulated to facilitate such in-situ repairs with more confidence and ease.

On 30.08.2019, Unit No.-3 of the power station tripped on stator earth fault. From the disturbance recorder, it was observed that voltage in Y-Phase dipped from 8.0 kV to approx. 3.5 kV, with no substantial increase in phase current, indicating an earth fault in Y-Phase. The phase voltages and currents in R-Phase and B-Phase were found to be normal. Insulation Resistance (IR) of Y1 path was found zero.

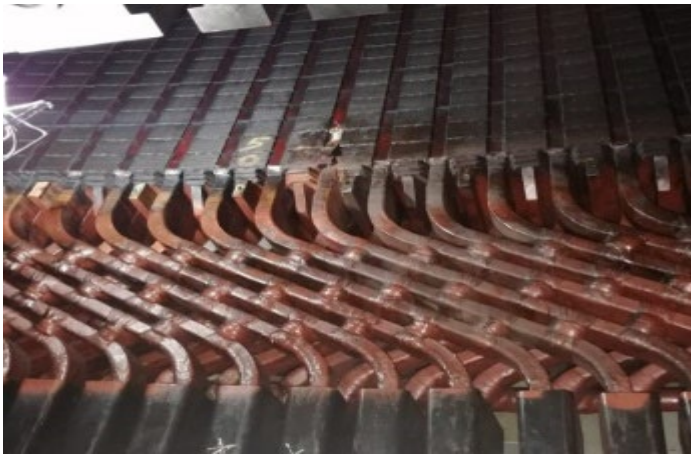
Visual inspection of winding and core shown some flashover in lower area of the winding near Slot No.-51 (Fig. 1 and Fig. 2). Winding Bars in Slot no-51 segregated and IR was tested on them. Results were satisfactory. Further sectionalization of winding in faulty path (Y1) was carried and IR tests carried out.

Fig. 1: Visual Inspection - Rotor Poles removed

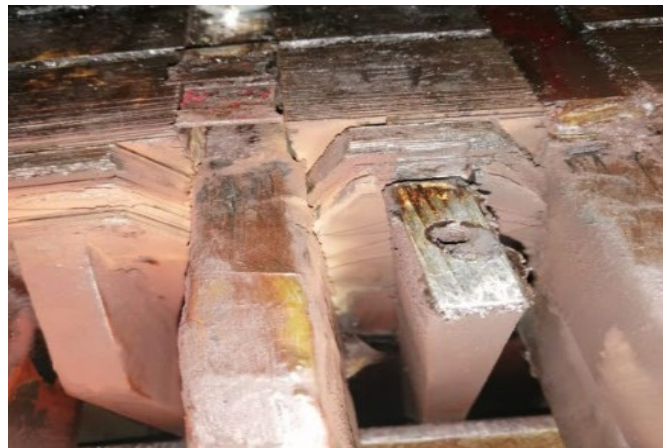
Fig.2: Burnt out Step Laminations

During inspection of the area around the seat of fault it was observed that the step laminations and finger of slots 50, 51 and 52 in the lower end area of stator core were found damaged due to heating. lamination packets between slots 50, 51 and 52 were found disturbed/loosened (Fig. 4). Two number air ducts just above the packet of loosened laminations were found blocked.

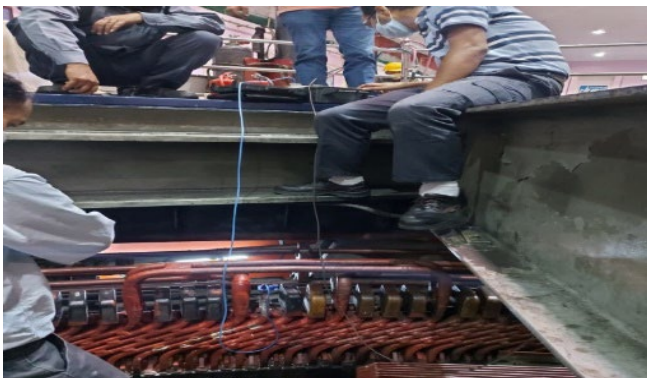
IR of a section of winding covering around 25 slots found zero. To avoid further sectionalization, controlled DC up to 60-70 amperes, was injected in the faulty section of winding using a welding machine. Minor spark was observed in slot-52. Bars in the slot were segregated. IR of bottom bar in slot-52 was found to be zero (Fig. 3).

Fig. 3: Testing of Stator Sections

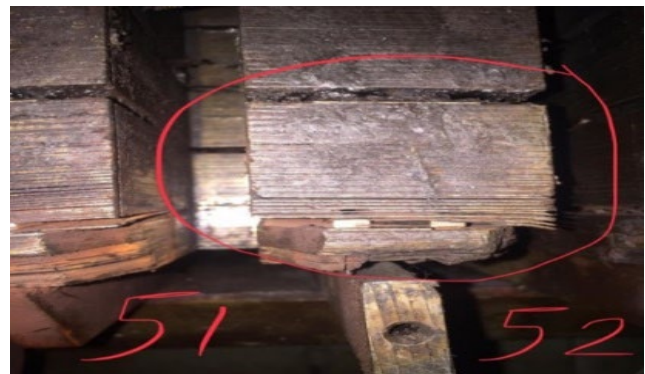
Fig. 4: Loosened Laminations

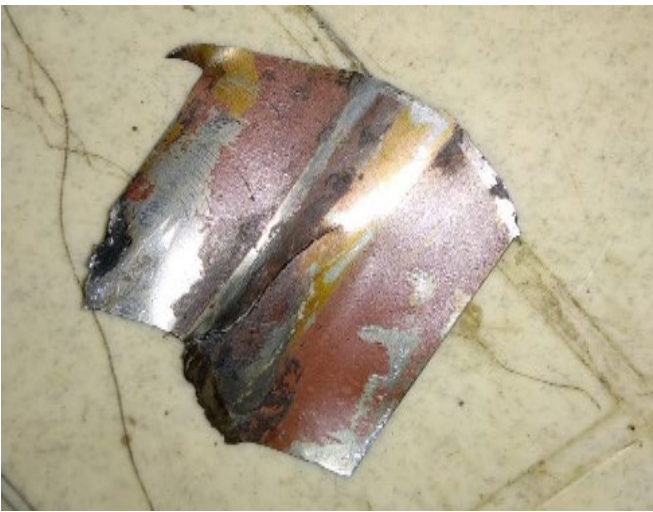
Outer edges of about 15 laminations in lower most portion had vaporized completely while partially burnt-out edges of of about 25 laminations were in place. A piece, measuring 50 x 50 mm (Fig. 5), of one such lamination between Slot-51 and 52 had got torn from the remaining lamination and moved from its place by about 2-3 mm. Upon inspection of the punctured bottom bar, a cut-groove about 25mm in length, 2-3 mm in width and 2-3 mm in depth was observed (Fig. 6). The position of the groove was corresponding to the displaced piece of step lamination. Thus, it was concluded that the displaced piece of step lamination had gradually cut into the bottom bar in slot 52, thereby puncturing it and resulting in earth fault at the point of puncture.

Fig. 5: Torn-out Piece of Lamination

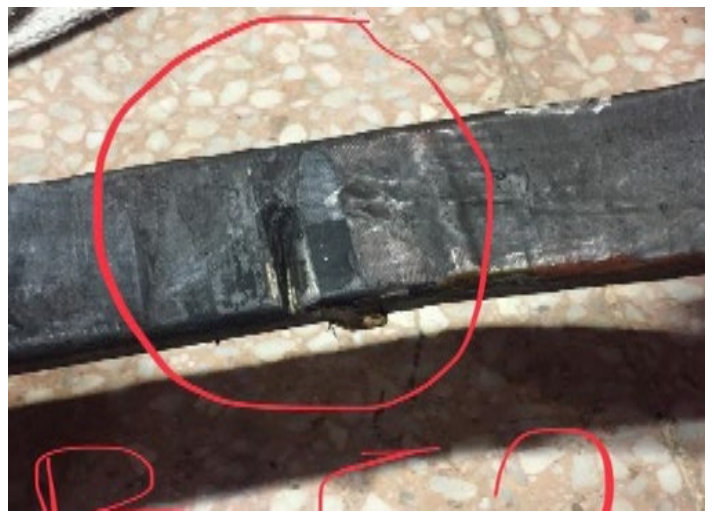
Fig. 6: Damage on Bar due to Lamination Piece

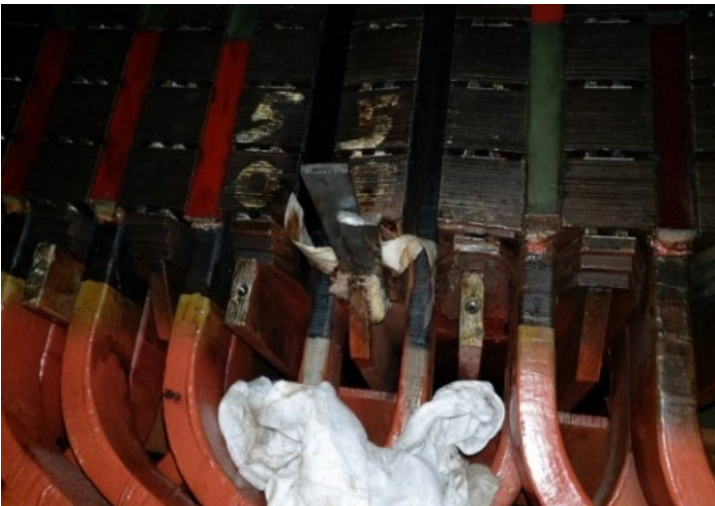
Fig. 7: Localized Repairs Undertaken

- Removal of Bottom bars in slot 50 and 51
- Removal of remaining identified bars, to facilitate the repair work of core laminations.
- Removal of rotor poles
- Removal of stator hot air coolers for cleaning and inspection of back of the stator core
- Removal of burnt-out outer portions of the laminations
- Cleaning of area around and in between the laminations including the air ducts
- Insertion of core insulation varnish in between the laminations
- Preparation of nomax paper packing (nomax paper dipped in epoxy varnish)
- Insertion of above packing in between the laminations for providing tightness and insulation (Fig, 7).
- Preparation of packing (wool-felt dipped in epoxy varnish)
- Insertion of above packing in between the laminations for providing tightness and insulation (Fig, 8).

- Reopening of the air ducts blocked by debris.
- Checking/tightening of stator core bolts.
- Replacement of damaged winding bars in slot 52 (2 bars)
- Replacement of other bars (14 numbers, removed for replacement of the bottom bar in slot 52.
- Repair of damaged core
- Testing as per procedure.
- Cleaning of entire stator core air ducts and winding overhang.
- ELCID test of stator core carried out and found satisfactory.
- Application of core varnish and semiconductor paint and left for drying.
- Insertion and assembly of rotor poles carried out.
- Refitting of stator air coolers which were removed.
- Final inspections
- Final testing, cleaning.

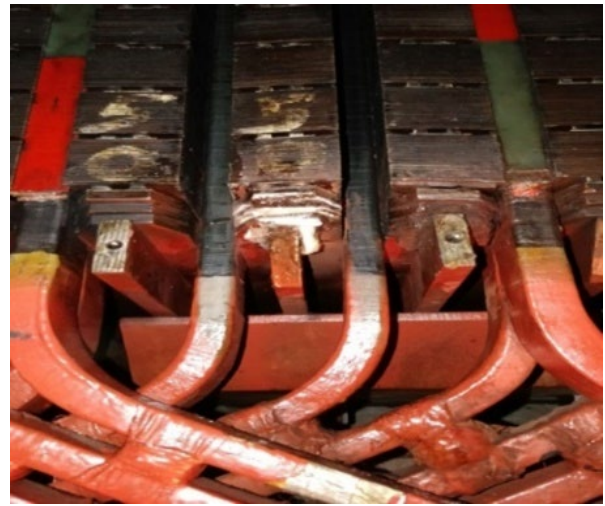
Fig. 8: Repaired Laminations

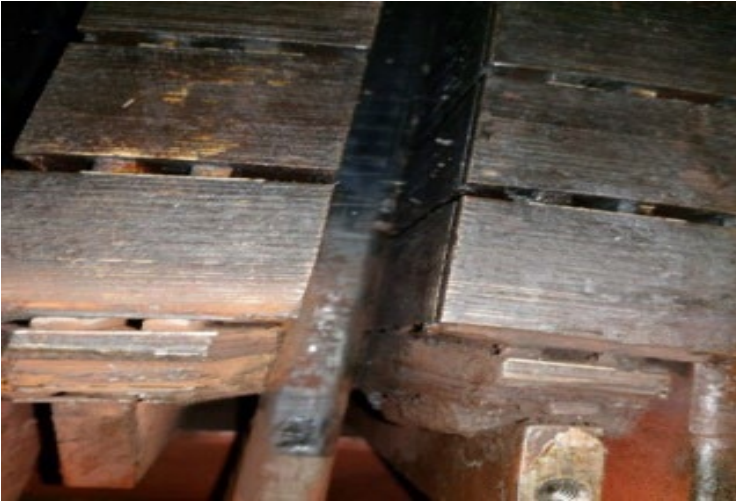
After a period of around one year (on 18-07-2020), a similar problem reappeared in another section of the stator. This time, the outer visible edges of step laminations in the lower end of the stator core (between slot 50 and 51) had got heated up, leading to vaporization of some laminations and loosening of step laminations between slot 50 and 51. Also, the packet of laminations just above step laminations had also loosened (Fig. 9). A piece, measuring 25 mm x 25 mm (Fig. 10) of one such laminations between Slot-50 and 51 had got torn from the remaining lamination and got displaced from its position by about 8 mm to 10 mm. This piece cut a groove of about 20 mm x 2 mm and 1-2 mm depth into the top bar in slot 51, thus puncturing and grounding the top bar.

Fig. 9: Loosened Laminations

Besides this damage, no damage or deterioration was observed in the laminations in adjacent slots repaired in the previous year. The fault was repaired in exactly the same manner and by adopting the same process as adopted in previous year.

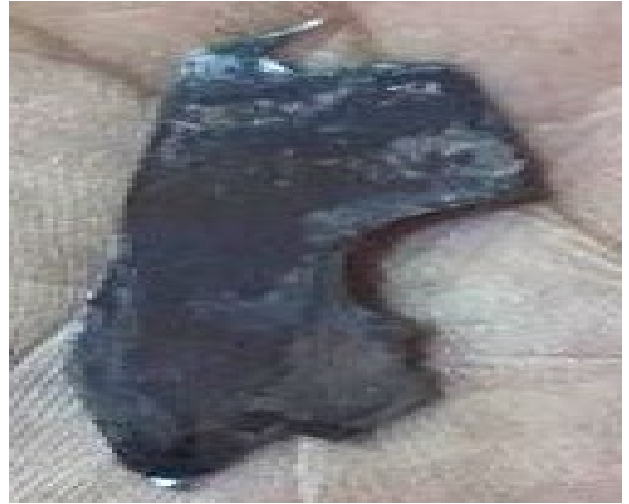
Fig. 10: Piece of Lamination

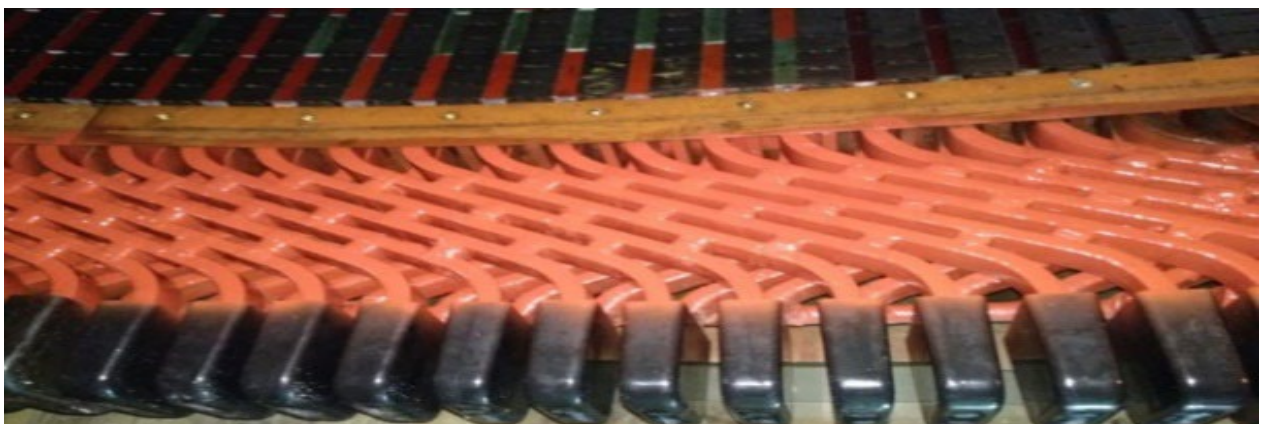
During both the occasions of breakdown, the fault had occurred during peak season. Thus, the restoration work was to be carried out within minimum possible time with satisfactory level of repair outcomes (Fig. 11) and post repair unit operation. The equipment manufacturer had indicated that a viable and immediate solution may not be possible since the fault was in lower areas of the stator core, thus calling for a rebuild of the entire core. If, as per recommendation of equipment supplier's team, core build up was to be taken up, an expenditure of somewhere around INR 150 million (\$ 1.8 million) would have incurred. This process would also have led to Plant Availability Factor loss and generation loss for at least 8 to 12 months. Since the fault was in a small portion of the stator core, it did not make sense to go for the entire core build up besides incurring huge losses on generation. Accordingly, contrary to the views of the equipment supplier, it was decided to take up the localized repair works. The first repair took 56 days. The repair time was significantly reduced to 13 days in the second repair, due to adoption of the process devised out during first repair. The direct savings on this account during both the incidences were substantial, due to reduced consultancy (from equipment supplier) and repair costs, and outage time saved by adopting the devised process. Further, considerable savings on account of generation loss were also made which cannot be precisely estimated, the power station being a reservoir scheme.

Fig. 11: Lower Overhang Area after Repairs
