Seismic Vulnerability Assessment Using FEMA P-154 and Welded Mesh Reinforcement in Informal Settlements in Peru

Abstract - The main objective of this study is to evaluate the seismic vulnerability of 30 self-built houses in the Juan Pablo II human settlement in San Juan de Lurigancho, Lima, Peru, which, due to their informal construction and the use of low-quality materials, present a high risk of seismic events; To do so, the FEMA-P154 methodology will be used, revealing that 31% have a risk of collapse greater than 50%. Likewise, the results of this research will allow us to identify the main structural deficiencies and propose appropriate reinforcement solutions, thus contributing to improving the safety of the inhabitants of the area and reducing human and material losses in the event of an earthquake. This study evaluates the alternative of welded mesh as a reinforcement proposal to improve the seismic behavior of the houses, which will be evaluated through dynamic and pushover analysis, using tools such as AutoCAD and Etabs to perform structural analysis.

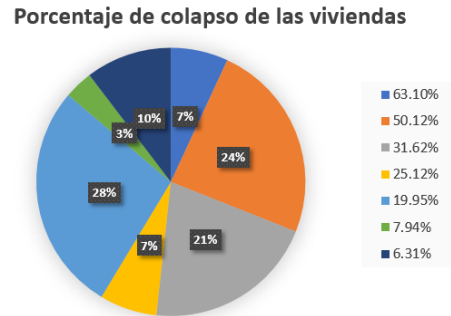
After carrying out a detailed vulnerability assessment using the FEMA P-154 method on 30 homes, it was determined that 7% have a collapse percentage of 63.10%, and 28% have a 19.95% prone to collapse, as shown in Fig. 1. In addition, Fig. 2 and Fig. 3 show the characteristic value of the most influential factor of the homes in each parameter.

Fig. 1: Percentage of housing collapses in the study.

The vulnerability assessment, carried out using the FEMA P-154 methodology, reveals a worrying picture regarding the seismic resistance of the homes analyzed. An alarming 31% of the buildings present a risk of collapse greater than 50% in the event of an earthquake, which classifies them as highly vulnerable structures. Likewise, an additional 28% exhibit a moderate risk of collapse, ranging between 20% and 50%. Only the remaining 41% show a low risk of collapse, less than 20%.

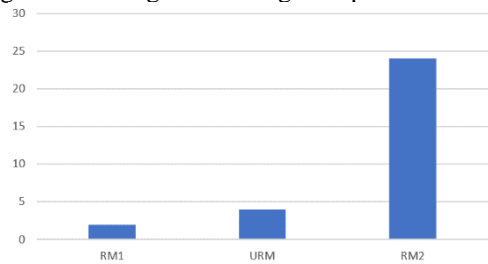
Fig. 2: Structural system according to FEMA.

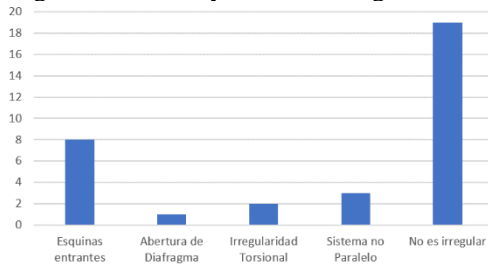
Fig. 3: Classification of the homes under study by irregularity in the floor plan.

The presence of geometric irregularities in plan and elevation, such as incoming corners and out-of-plane setbacks, generate stress concentrations that compromise the structural integrity of buildings. These irregularities are particularly dangerous in seismic zones, as they can trigger complex and difficult-to-predict failure mechanisms.

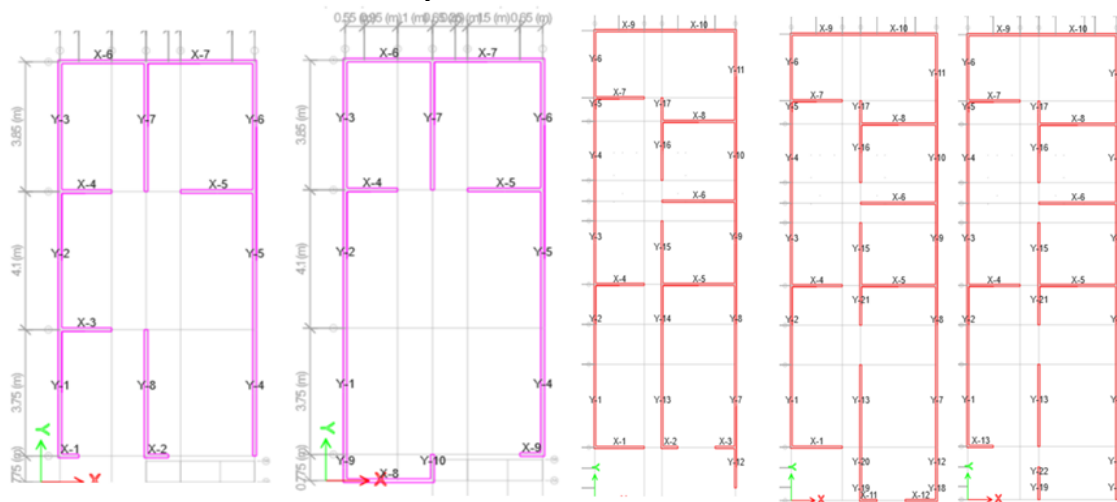
Fig. 4: Floor plan of the levels of housing 22 and 16.

To continue with the control of wall cracking, it can be seen in Fig. 4 how the walls were named at each level of the houses. In addition, the shear forces to be used for the subsequent analysis will be when the house is in a dynamic state, since there is a greater demand for work to be resisted by the walls.

The static and dynamic spectral structural analyses carried out in houses 16 and 22 reveal poor seismic performance in both buildings. In the case of house 22, 3 walls are identified that, under seismic action, would be subjected to shear forces greater than their resistant capacity, which would cause them to crack. On the other hand, in house 16, this situation occurs in 11 walls. As a reinforcement measure, the addition of electro-welded mesh to one side of the walls was proposed. This solution was effective in ensuring the shear-resistant capacity of all the walls of houses 22 and 16.

As a reinforcement measure, the addition of electro-welded mesh to one side of the walls was proposed. This solution was effective in ensuring the shear-resistant capacity of all the walls of house 22. However, in house 16, despite the significant improvement in the resistance of most of the walls, 9.52% of them still do not fully meet the design requirements. In these particular cases, improvements in the resistant capacity of at least 57.70% (wall X-1, floor 1) and up to 135% (wall Y-1, floor 2) will be observed.

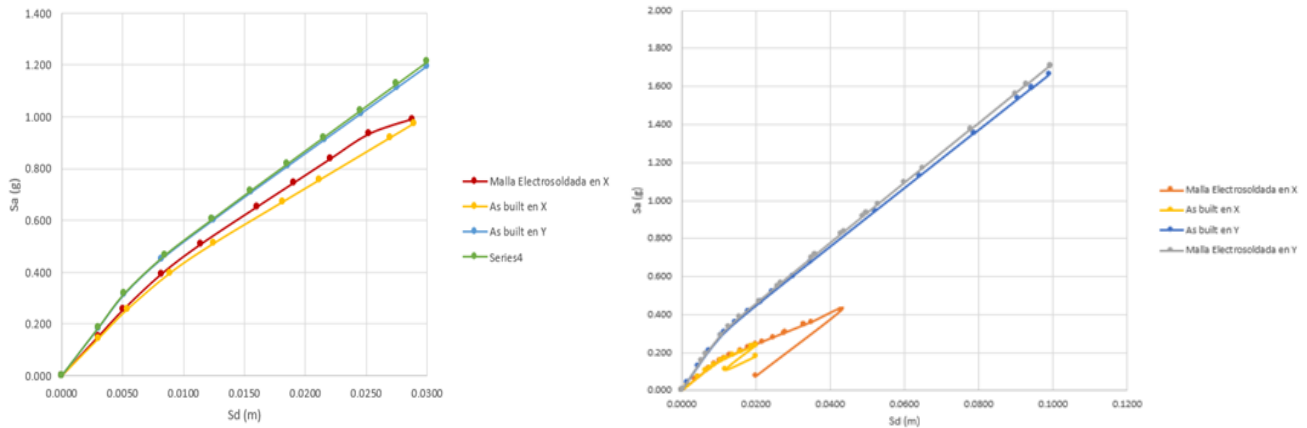
For the analysis, it is necessary to have the non-linear conditions of a conventional masonry wall and one reinforced with welded mesh calibrated against an experimental model. For the hinges of the masonry walls and with the reinforcement in non-linear conditions, those proposed by [9] were used. Accordingly, the capacity curve is determined as shown in Fig. 5, both As built and reinforced with welded mesh in both houses in both directions.

Fig. 5: Capacity curve on X and Y axis of housing 22 and 16

In terms of ductility, the deformation capacity of the reinforcement is very similar to that of the As Built house. The reinforcement improves the shear resistance in the X direction of house 22 by 1.62%. While in the Y direction, it improves by 1.50%. On the other hand, in house 16, an increase in capacity of 1.34% was obtained in the X direction, while in the Y direction, 2.99% of its initial capacity

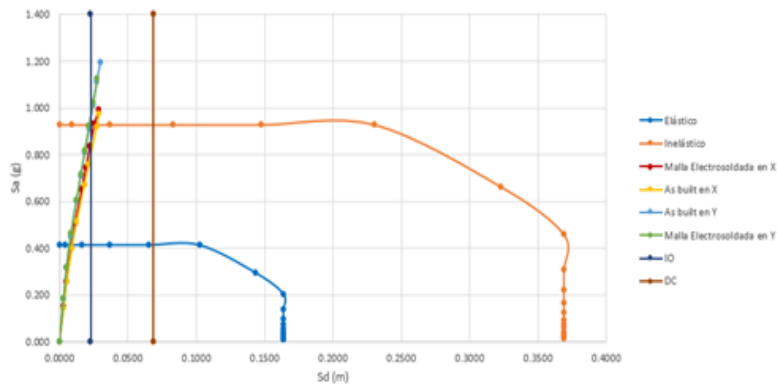
Fig. 6: Capacity Spectrum – Housing Demand 22

The structural analyses carried out in houses 16 and 22, using the pushover method and the comparison with demand spectra, allow their seismic performance to be evaluated and classified according to the damage levels established in the ATC-40 regulations. On the one hand, the structure of house 22 presents a performance level classified as Damage Control (DS) in the limit states of P.D.3 and P.D.4. This indicates that, in the event of a design earthquake, moderate to severe structural damage could be expected, without compromising the safety of people. However, the damage caused would require considerable repairs and could affect the habitability of the house. On the other hand, the results obtained for house 16 show a performance level classified as Life Safety (LS) in the limit states of P.D.8 and P.D.9. This level indicates that the structure could suffer very severe structural damage in the event of a design earthquake, which could put the lives of the occupants at risk and would require extensive repairs or even the demolition of the house.

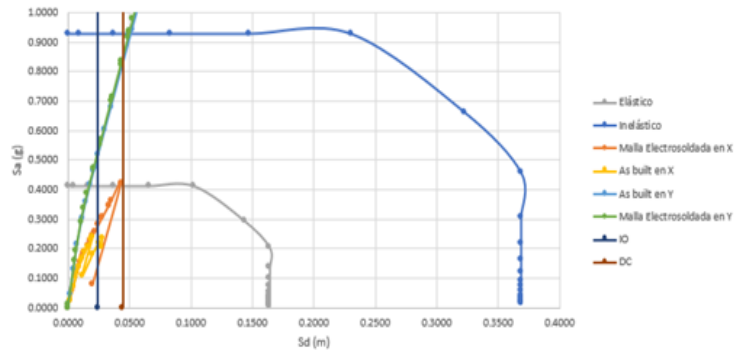
Fig. 7: Capacity Spectrum – Housing Demand 16
