Seismic Vulnerability Analysis Using Qualitative and Quantitative Methods and Structural Strengthening Proposal for Self-Built Dwellings in Latin American Informal Settlements

Dago Tipacti¹, Gram Y. Rivas²

¹Department of Civil Engineering, Universidad Tecnológica del Perú (UTP)
Av. Petit Thouars 116, Lima 15046, Lima, Perú
1630921@utp.edu.pe ; c20900@utp.edu.pe

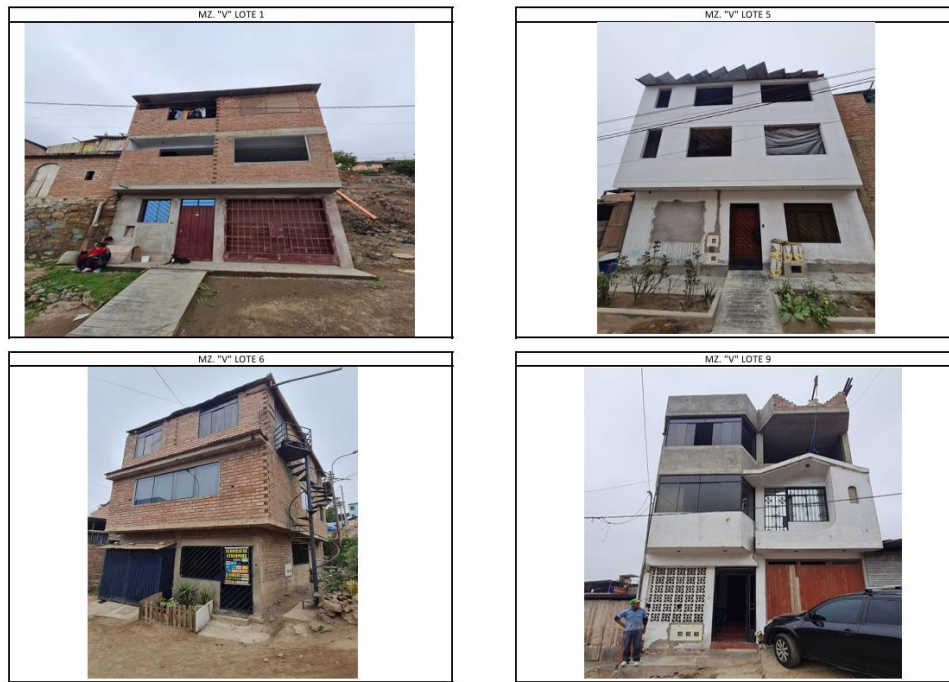
Fig. 3. Images of Residential Structures in the Puyusca Informal Settlement

Figure 3 shows a sample of the dwellings surveyed during the fieldwork, while Figure 4 presents the floor plans of three representative housing units selected for quantitative evaluation based on interstory drift ratios.

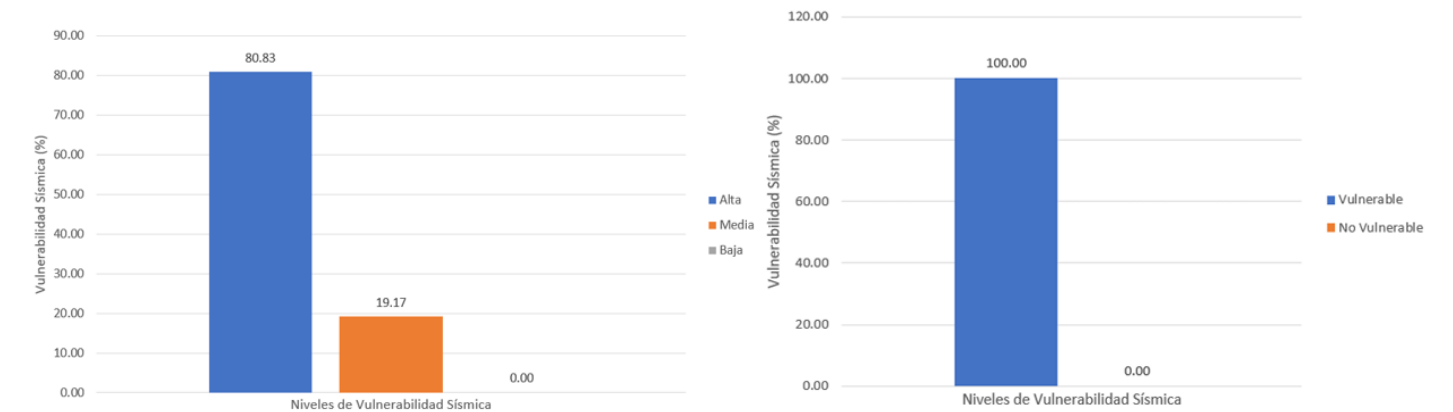
Fig. 5. Seismic Vulnerability Results of Dwellings According to Benedetti-Petrini (left) and FEMA P-154 (right)

Figure 5 shows the seismic vulnerability levels of the dwellings according to the Benedetti-Petrini method. It is evident that more than 80% of the houses exhibit high vulnerability levels. On the right side of the figure, the FEMA P-154 results are presented, which indicate that 100% of the dwellings evaluated fall within the vulnerable category.

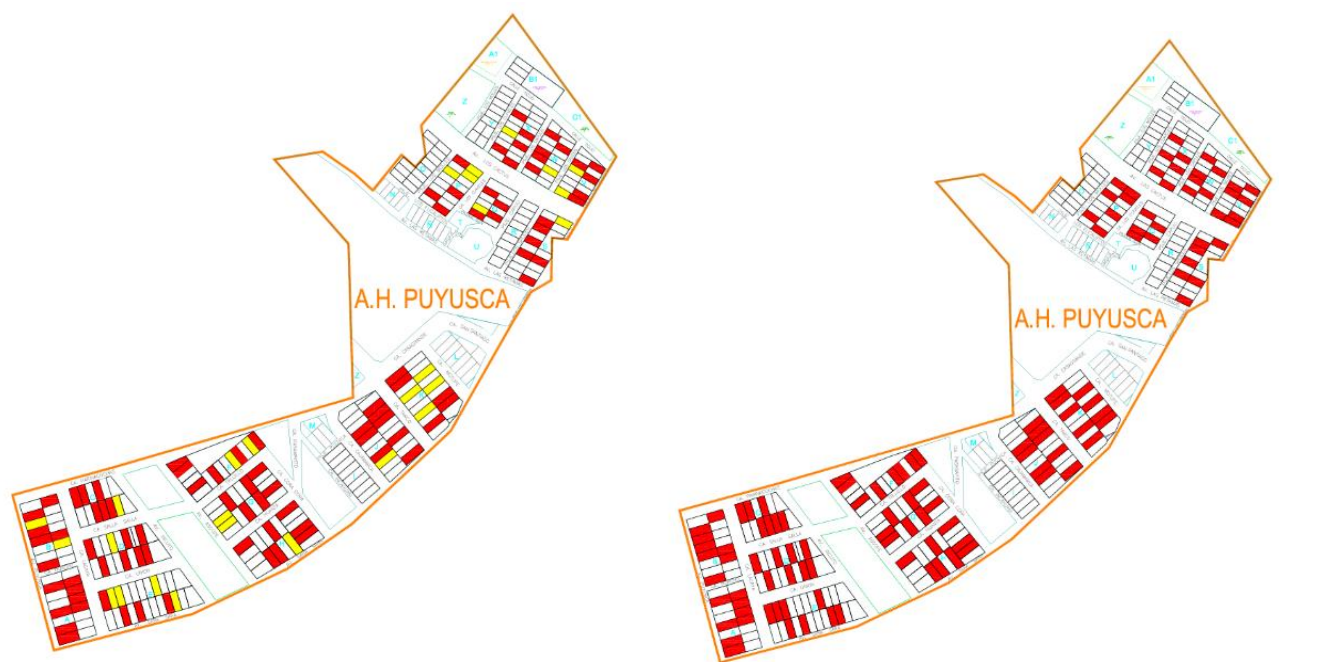
Fig. 6. Seismic Vulnerability Maps According to Benedetti-Petrini (left) and FEMA P-154 (right)

Figure 6 provides the seismic vulnerability maps generated from both rapid screening methods. These maps underscore the critical need for structural intervention, as a considerable portion of the housing stock may suffer significant damage in the event of a high-magnitude earthquake.

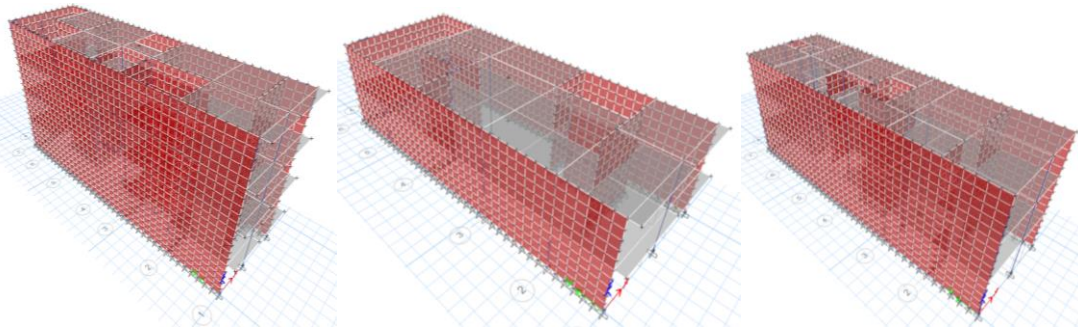
Fig. 7. ETABS Models of Dwellings: V01 (left), V02 – 2 stories (center), V03 – 3 stories (right)

Next, Figure 7 displays the ETABS models of the three selected dwellings, and Figure 8 illustrates the interstory displacements and drifts obtained from the structural analyses.
