# Comparison of the FEMA P-154 Methodology with Seismic Analysis in the “Galería Tradición” of Cercado de Lima

**Abstract** - The seismic vulnerability of buildings with considerable age represents a crucial challenge for urban resilience in a historic city like Lima. In this research, a sample of 30 publicly accessible galleries within the Cercado de Lima was evaluated. These structures were built with now-obsolete structural systems and are subject to deteriorated conditions. The FEMA P-154 methodology was applied to conduct rapid visual inspections and to classify the structures according to their level of seismic vulnerability based on the score established by the format. Additionally, a gallery with a critical FEMA score was selected for structural modeling in ETABS using previously scaled historical seismic records, following the guidelines of the E.030 Seismic Design Code. A Schmidt hammer test was also conducted to estimate the concrete strength of the selected building. The results show that more than one-third of the buildings exhibit high vulnerability and that the drifts obtained in the dynamic analysis exceed the limits established by the E.030 code. The FEMA P-154 me

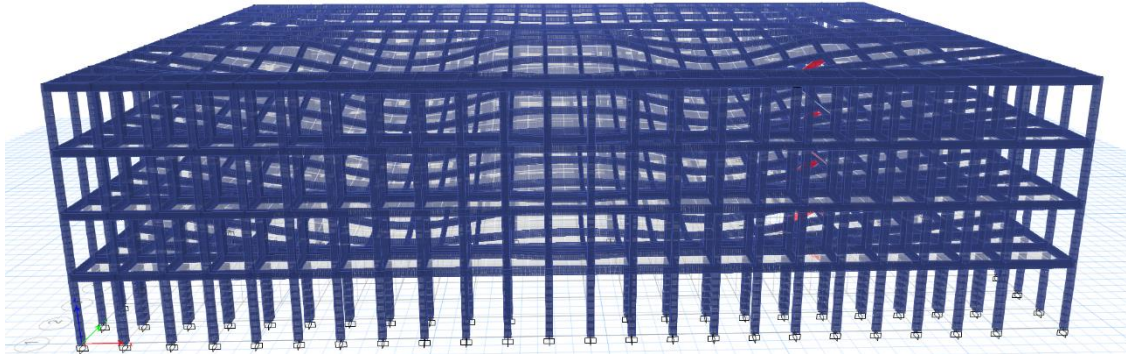
Fig. 4: ETABS Modeling of the Galería Tradición

As a complement to this preliminary evaluation, a building Galería Tradición was selected for structural modeling using ETABS software, with the objective of analyzing its dynamic behavior in greater detail under seismic events.

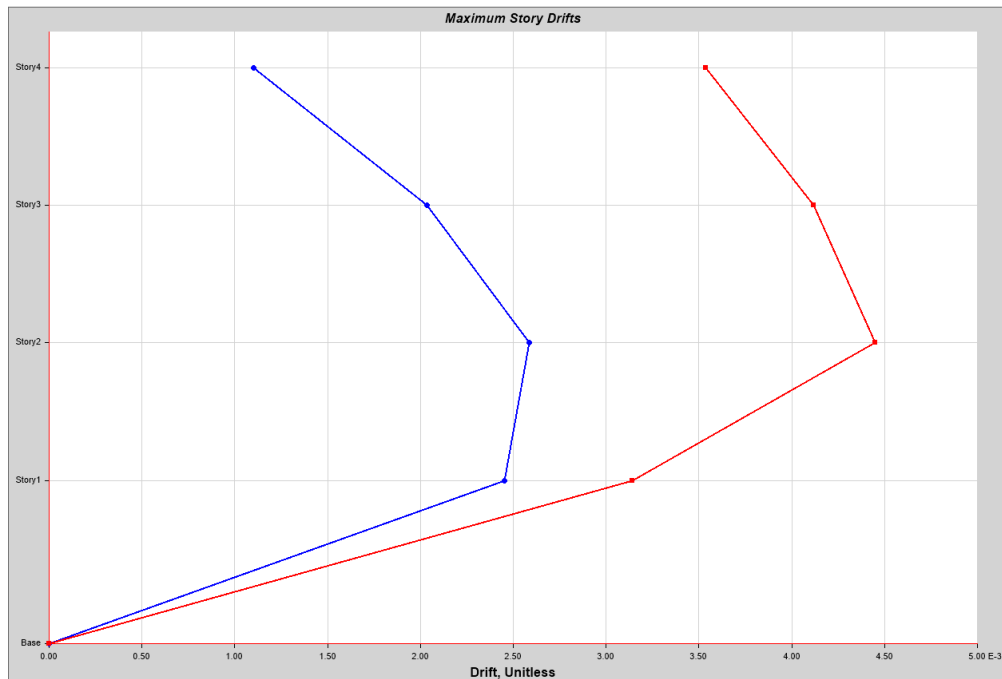
Fig. 8: Graph of the drifts obtained with the Etabs software

EARTHQUAKE OF 66						
Floor	Displacement of C.M. in X (m)	Drift in X	E.030 Standard	Displacement of C.G. in Y (m)	Drift in Y	E.030 Standard
4	0.02109	0.0011	complies	0.03708	0.00354	complies
3	0.01864	0.00203	complies	0.03023	0.00412	complies
2	0.014	0.00259	complies	0.02067	0.00445	complies
1	0.00775	0.00245	complies	0.00943	0.00314	complies

Additionally, to validate the result provided by the FEMA P-154 method, a dynamic seismic analysis was performed using the ETABS software. This analysis confirmed that the interstory drifts, when subjected to seismic excitations, did not exceed the 0.007 limit established by the E.030 Seismic Design Code. Therefore, in the event of a major earthquake, the structure would not experience severe inelastic deformations, helping to ensure the safety of both the building and its occupants.
