Slope Drainage Design and Operation: A Study of Legacy Assets

Elena Mugarza¹, Stephanie Glendinning¹, Ross Stirling¹, Colin Davie¹

¹ Newcastle University School of Engineering Newcastle Upon Tyne, United Kingdom e.mugarza@newcastle.ac.uk

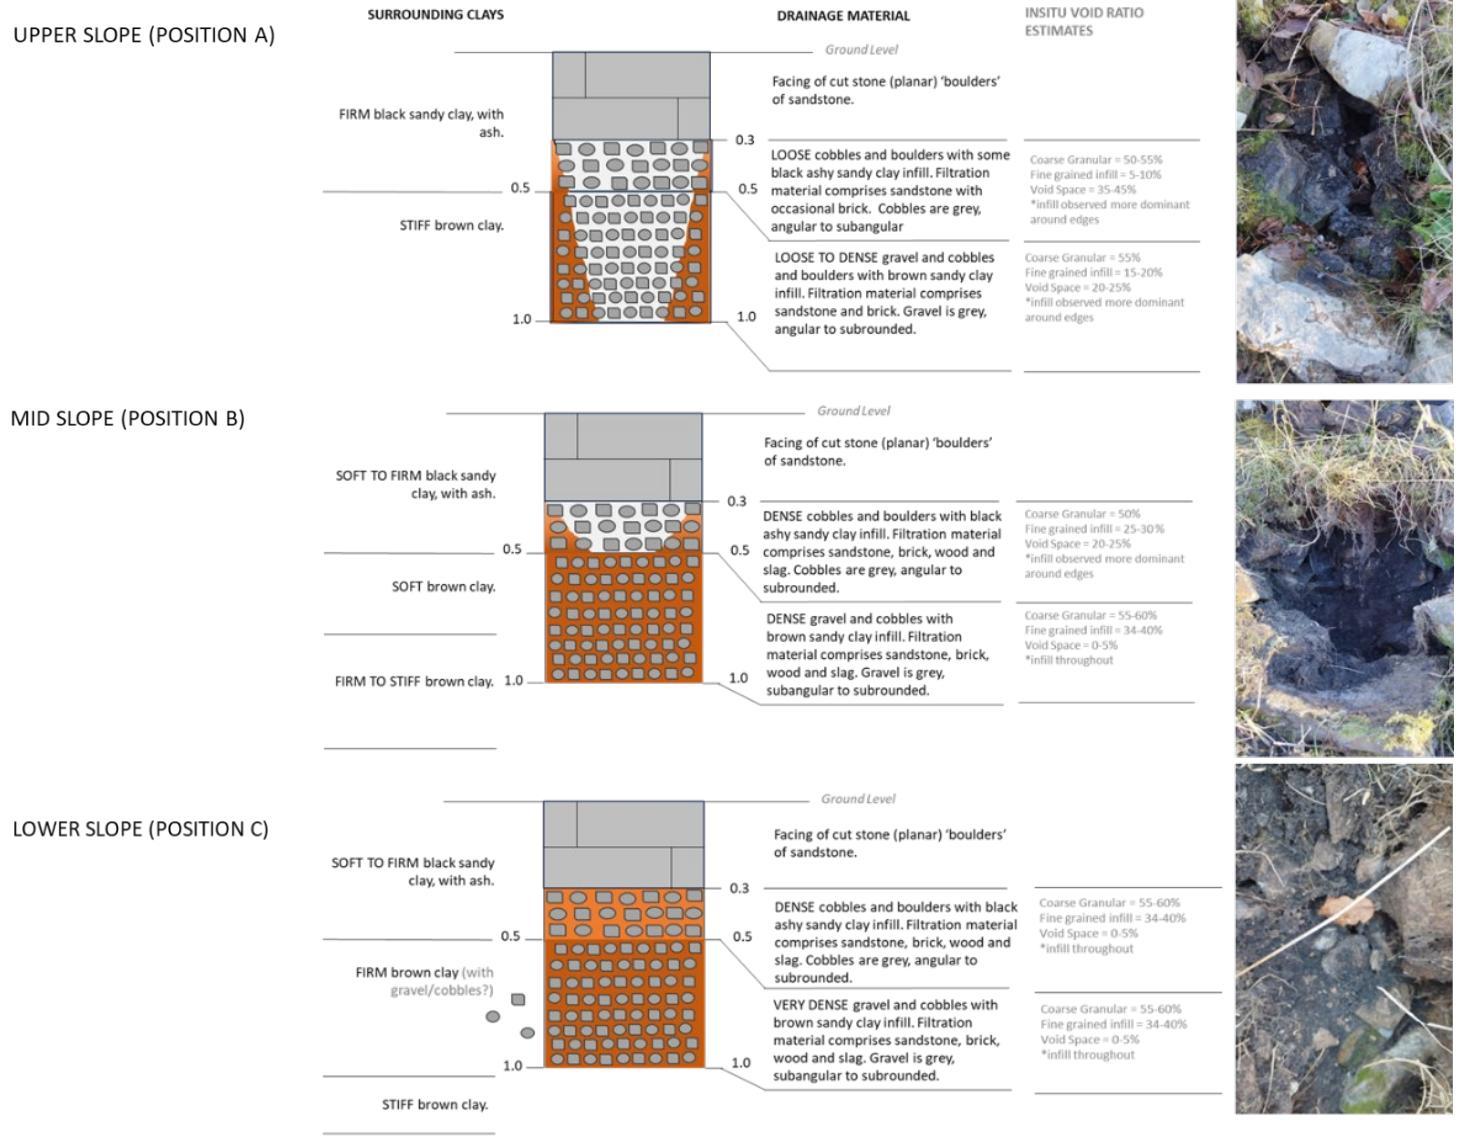
Fig. 2: Visual Investigation Record

The visual survey record for all drainage positions, with descriptions adapted to results from laboratory and in situ testing is shown in Figure 2 below. The presence of voids and clay encroachment into the drain was recorded, though this was limited to qualitative, visual observations. There is evident variation in drain compaction and clay content at locations both up and downslope. With the granular material at the most upslope position of the drainage trench noticeably more loose and with reduced fines content when compared with positions downslope. It was observed that the clay encroachment increased with depth in all positions, with Investigatory Position C completely impassible to water. Photos have been included for visual evidence of anecdotal descriptions and efforts were made to keep the materials extracted as undisturbed as possible for review and representative sampling in further laboratory testing.

It is notable that in modern earthwork drainage design details, gravel particle sizes are considerably smaller than those found at this site, which can be described as coarse gravel and cobbles which are not reflective of current best practice (British Standards Institute 2022). Additionally, modern design details would typically include a suitable perforated pipe connected to an outflow at the toe as well as a geotextile surrounding the drain to limit the lateral movement of fine material. The inclusion of these reduces the deterioration of the drain itself but does require increasingly frequent maintenance and replacement, up to every 10 years (Network Rail 2021).

Clay content in drainage voids is shown to increase with both vertical depth of drain and distance downslope caused by the gravitational movement of water and carried fine particles. The presence of fines in the drain reduces the free flow of water through the drain and can cause the backing up of such water in a storm event. It is noted that these drainage assets are assumed to be more than 60 years in age, with no record of maintenance activities. This example is representative of the impact of both superseded design details that preclude the use of geotextiles for fines protection or water conveying perforated pipes, together with negligeable maintenance.

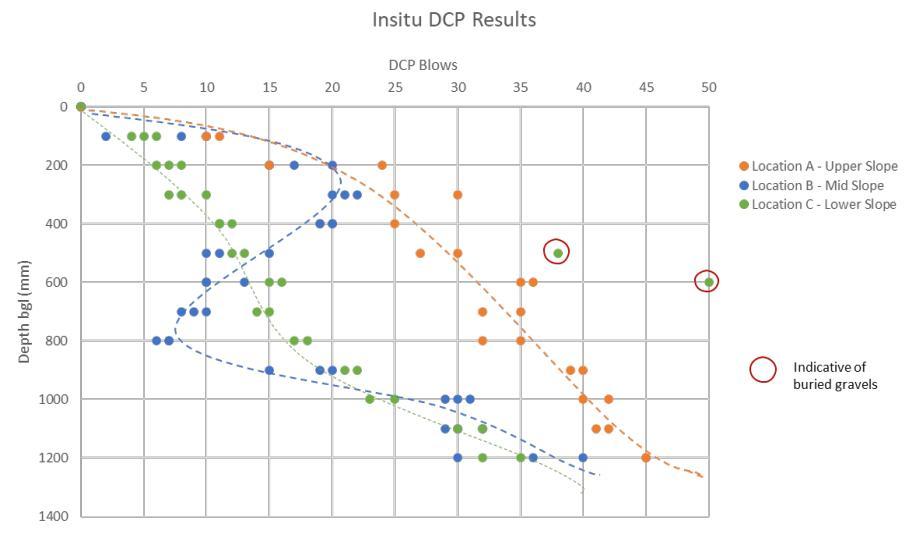
Fig. 3. In situ Dynamic Cone Penetrometer (DCP) results adjacent to drain.

In situ DCP results are shown in Figure 3. In the case of the investigation example, softening of the clays surrounding the mid and lower slope drains are visible, with areas of softening from 0.5m depth and below. The results circled in red are reflective of test termination due to the presence of drainage gravels that have spread into the clay surrounding. In all positions DCP tests were conducted a total of three times.

The DCP values and distribution demonstrate the softening of the clays surrounding the mid and lower slope. It is considered that this is caused by the inability of the drain to successfully convey excess water and its subsequent storage within the drain. The softening of the clay immediately around the drain is then caused by the outward egress of water from the drain of this stored water, though this mechanism is clearly not proven. The most pronounced demonstration of this mechanism is at the mid-slope (point B), where the clay encroachment into the drain is partial, but further movement of water downslope is prohibited by the completely clay encroached region of the drain beneath this point down the slope. If the DCP results are used to calculate Uniform Compressive Strength (UCS) these give a range of values of between approximately 100-1300kPa (Alshkane, Ahmad Rashed and Daoud 2020). The UCS of soils is observed to have a detrimental impact of slope stability and reflect a weakened plane the could potentially cause small scale rotational or more wide spread translational failures. There is also evidence to suggest the gradual pushing out of drainage material into the surrounding clays from its original trench location, occurring from the drain base and expectedly further up slope as the drain pore spaces fill and push outward progressively. The values that suggest this are circled and the rounding off of the drain boundary and merging of clays with filtration material was evident during the visual survey.

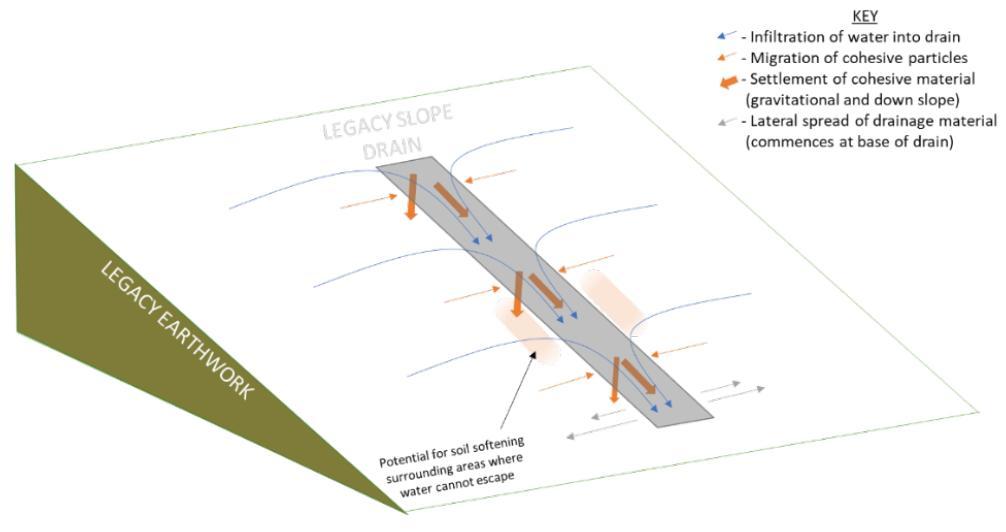
Fig.4: Movement Schematic Diagram

Figure 8 provides a visual summary of the hypothesis proposed movement processes occurring over years of repeated storm cycles, evident through this investigation. These deterioration mechanisms include the fines material wash out from surrounding clays into the drain voids, the settlement of this material vertically within the drain, and down-slope within the

drain. This is accompanied by gradual lateral push-out of gravel material into clay soils surrounding the drain, causing a blurring of the drain-clay boundary. This phenomena occurs firstly at the base of the slope drain and then gradually works upwards, as the drain voids are filled at mid and upslope positions. Additionally, softening of surrounding clay occurs as it is exposed to water held within water pockets in the gravel that are surrounded by clay that is inhibiting its movement downslope.
