Probabilistic analysis of slope stability in Soils and Soft Rocks

Abstract – Slope stability poses serious problems in Costa Rica due to its geographical position and geological characteristics. It is important for geotechnical engineers and designers to use analysis methods which are accurate and reliable when analyzing slope stability. The combination of deterministic and probabilistic methods provides more precise and reliable results. The present study evaluates the stability under four different conditions of two slopes, located at km 17 and km 29 of a national highway, between San Ramón and Quesada, in Costa Rica. A probabilistic method is used to estimate not only the safety factor, but the probability of failure, in order to come up with a safer and more rational slope design for this road section.

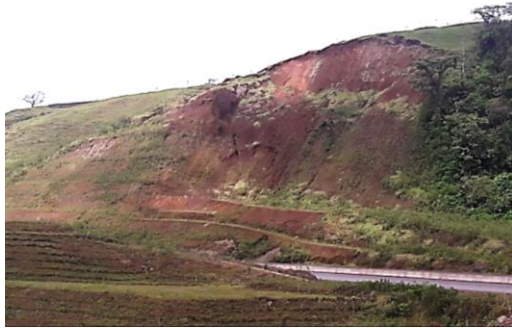
A. Slope on km 17

Two cut slopes were selected along a road construction project comprising a national highway sections between two cities, San Ramón and Ciudad Quesada. Figure 1 shows the slopes located at km 17 and km 29, which were selected, among other reasons, because of their accessibility. The SLOPE/W module from GeoStudio 2018 was used to perform the stability analysis.

Fig. 1: Slopes under study.

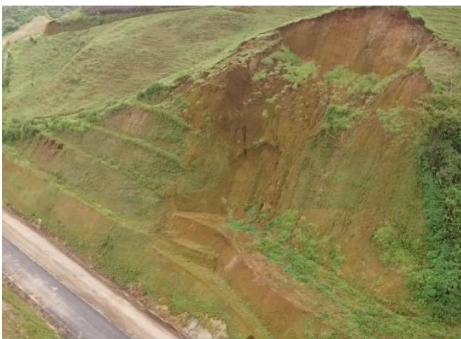
Figure 2 shows the cut generated with the road intervention, and the resulting landslide, as well as the model obtained.

A. Intervention and failure, slope at km 17.

Fig. 2: Slope at km 17 after intervention and failure.

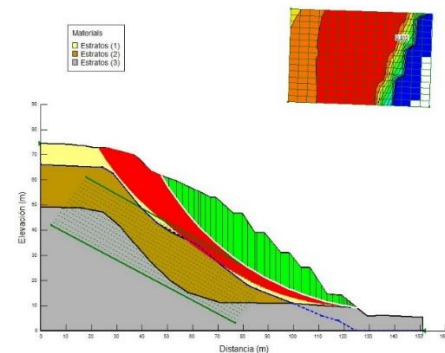
B. SLOPE/W output of slope failure after intervention, slope at km 17.

3. 3. Model after landslide (slope 17+100)

Based on the deterministic analysis, the slope is stable because the factors of safety in all cases are greater than 1, as specified by [5]. The probabilistic analysis for static cases shows that the factors of safety meet the criteria specified by [5]; however, the probability of failure in the saturated zone above the water table is greater than 1 %, thus confirming that slides can occur any time under this condition.
