# Social Housing and Its Pathological Manifestations: A Case Study in Piumhi, Brazil

**Abstract** – Due to the increase of the deficit of Brazilian social housing in the last years, many actions from public politics were conducted by the Federal, State and municipal governments, as the “My Home My Life” (MCMV) program, considered a solution to reduce the deficit. In Piumhi-Brazil 434 houses were built, where several pathologies were identified in most of the buildings, what contributes to reduce the quality of the life of the inhabitants. This research aims to study the quality of the buildings and presents a proposal of an initial BIM model of a building. This proposal sets an architectonic design that reaches criteria of housing, accessibility and sustainability. 273 houses were visited in 6 different housing estates in the municipality, what enabled to evaluate the conditions of the buildings. Based on the evaluation of questionnaires an architectonic design was developed considering the basic requirements from the inhabitants, updating the proposal of the standard constructed, using the software Revit for a 3D model. It is expected that the model proposed contributes to reduce

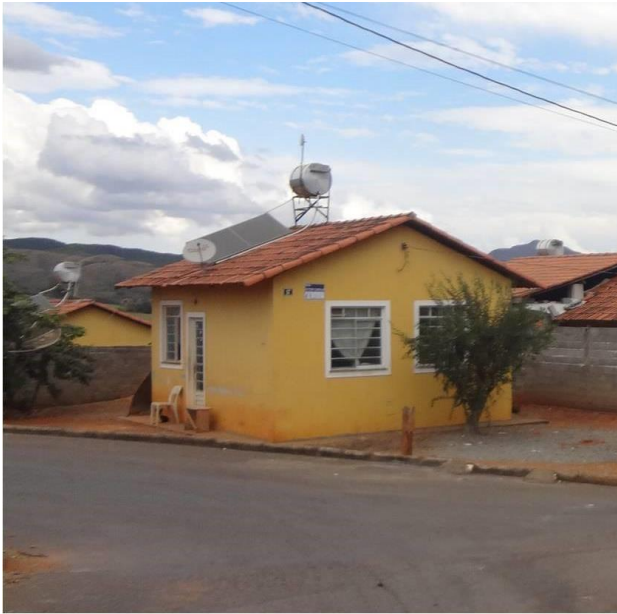
COHABMINAS is a state agency responsible for providing access to municipal housing and also supplying standardized project models. The standardized models of house was developed to reduce the price of housing in order to provide more social housings (Figure 2). The existing social housing complexes in Piumhi contain a living room, two bedrooms, a kitchen, a bathroom and a service area (single-storey building) (Figure 3). In Brazil, 35.72 m<sup>2</sup> correspond to a single family house.

Fig. 2: Housing standard in the municipality of Piumhi - Brazil.

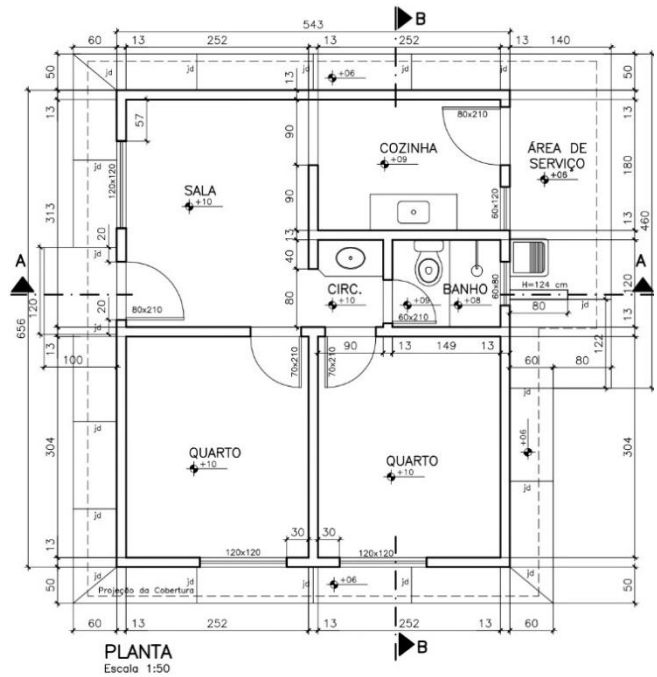
Fig. 3: Housing architecture and design.

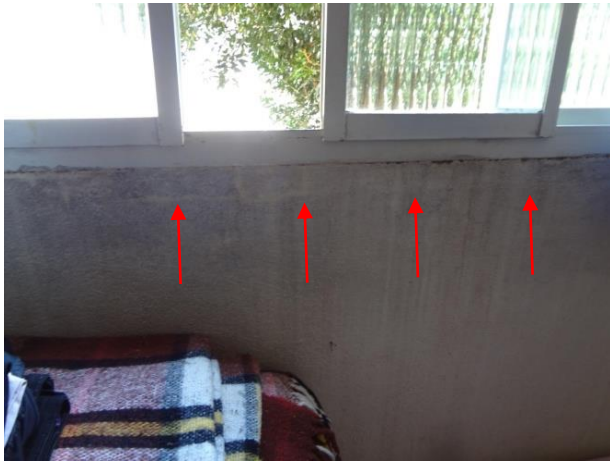
Fig. 4: Recurrent infiltration through the HIS window.

According to the critical problems (pathological manifestation) of buildings, it was noted that concerning the houses that were built in 2006, water infiltration could be detected in them, making up about 72%, and the most frequent water infiltrations could be found in the window (Figure 4). Approximately 90% have been facing problems with cracks in sealing masonry or in sidewalks of these buildings (Figure 5). Regarding the data obtained in the interview with the residents, through visual inspection of the dwellings and the analysis of the pathological manifestations in civil construction, a preliminary project was prepared in view of considering the requirements of quality and performance of a housing for the low-income earners.

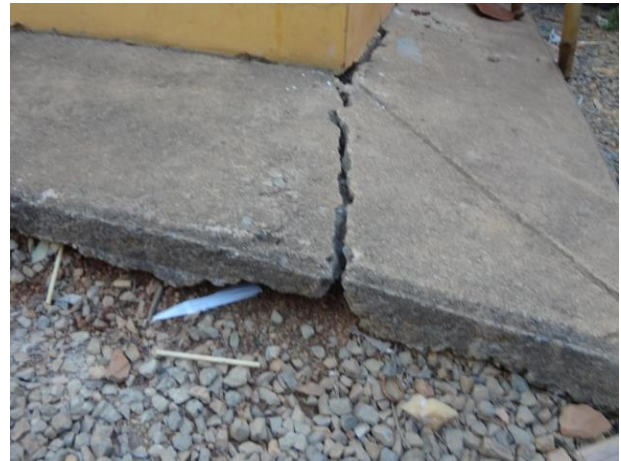
Fig. 5: Cracks in the HIS ride.
