Combination of UAV-Borne Lidar and UAV-Borne Photogrammetry to Assess Slope Stability

Stella Coccia¹, Marwan Al Heib¹, Emmanuelle Klein¹

¹Institut National de l'Environnement Industriel et des Risques (Ineris)
c/o Mines Nancy, Campus ARTEM, Nancy, France
stella.coccia@ineris.fr

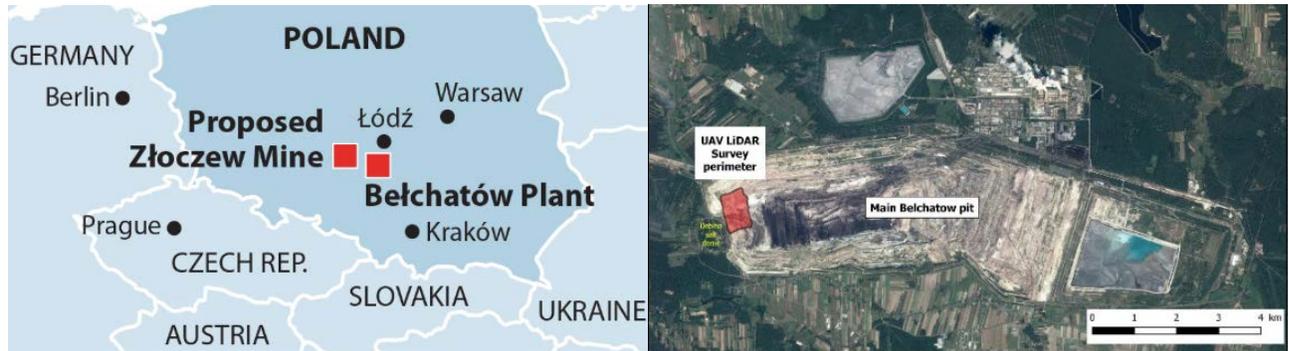
Fig. 1: Belchatow lignite open-mine (Poland) with the outline of the UAV LiDAR and UAV photogrammetry survey (about 800m wide and 1000m long).

Two UAV borne LiDAR and photogrammetric simultaneous surveys have been carried out on the western slope of the Belchatow mine (Area Of Interest, AOI, Fig. 1). The weather being a challenging factor over the winter period (wind, fog and snow cover), the field mission has been re-scheduled and delayed few times. Finally, the good weather windows for the multi-temporal survey were: on the 23rd November of 2016 and on the 31st March 2017. The campaigns were performed using a YellowScan Surveyor, which was at that moment one of the lightest (less than 1.6 kg) and most accurate LiDAR sensor solutions available on the market. The interesting aspects of this sensor was its accurate position and orientation direct georeferencing. In this project the YellowScan Surveyor was mounted on quad copter with a combo RGB camera.

The outline of the multi-temporal survey site is displayed in the following figure (Fig.1).

A total of 11 Ground Control Points (GCP) were picked up in the field in 2016 within the AOI (Fig.1). These GCP can be considered as targets with surface of 50cmx50cm. They had two purposes:

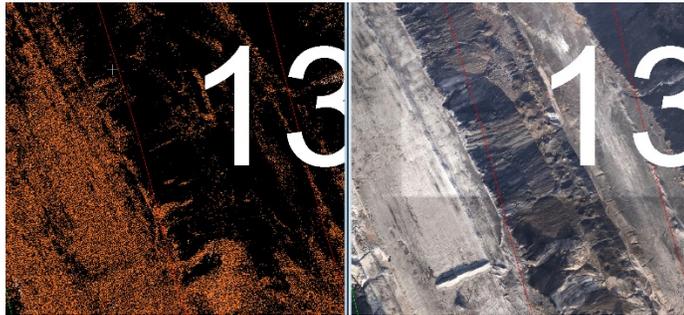
Fig. 5: to the left point density variation related to material nature (coal) shown on the orthophoto to the right.

- Reflectivity gaps – lignite related: multiple gaps of “no data” were found in the LiDAR dataset and over the southern portion of the AOI. These gaps appear to correspond to dark rock most probably related to their high lignite content (Fig.5). The alignment, location and size of the gaps occurring in the LiDAR dataset appear to depict the coal complex horizon. The point density over such rock falls down to about 3 ppsm. The LiDAR beam is completely absorbed. The impact of dark soil on the LiDAR is clearly exposed and does not seem to be affecting the photogrammetric point density.
