Monitoring of Global Warming Effects in High Alps

Yunlu Bai¹, Francesco Calvetti¹

¹Politecnico di Milano

In this paper, we discuss the design and installation of the monitoring station at Capanna Margherita hut (Punta Gnifetti 4554m a.s.l., Monte Rosa massif), which is the highest mountain hut in the Alps and in Europe in general.

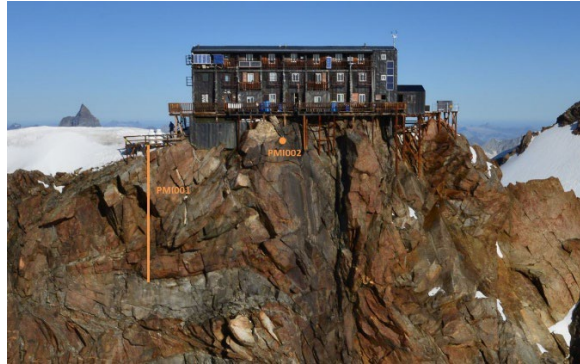
Figure 4 The vertical and horizontal boreholes position.

The first borehole was drilled vertically starting from the access platform to the hut. The vertical borehole reached a 20 m depth. The second one was drilled horizontally on the southeast rock face approximately 5 m below the balcony of the hut overlooking a length of 10 m (Figure 4).

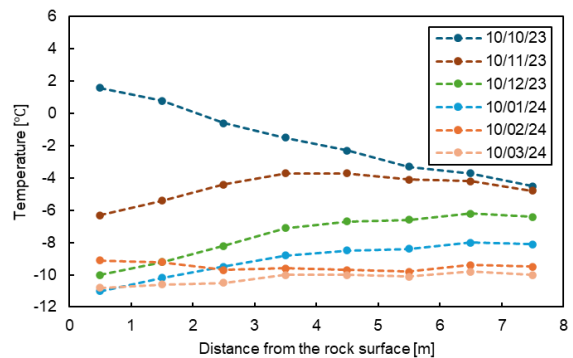
Figure 8 Temperature along the horizontal borehole.

Each modulus is equipped with temperature sensors and the temperature is recorded continuously. In the vertical column, 15 sensors are distributed with 1 meter step. Figure 7 shows the temperature recorded in the vertical column on the 10th of each month over the past five months (October 2023 to March 2024). It can be observed that in October 2023, temperatures near the surface are slightly higher than those at deeper levels, hovering around $-2.0\text{ }^{\circ}\text{C}$. However, it can be noted that November witnessed a sudden drop in temperatures, resulting in a significant decrease in surface temperatures while deeper temperatures remained largely unchanged. As temperatures continued to decline, a trend emerged where temperatures increased with depth. From November 2023 to March 2024, there was a greater temperature gradient near the surface, although this phenomenon became less pronounced over time. Figure 8 shows the temperature recorded in the horizontal column. The top of the borehole refers to the side near the exposed rock surface (the dip direction is 117° precisely), whereas the point 8 meters from the left is at the end underneath the hut, close to the ice cover of the west mountain slope. In October 2023, temperatures at the rock face were much larger than at depth. It is noteworthy that temperatures within approximately a 2-meter range from the exposed rock surface are above $0\text{ }^{\circ}\text{C}$ at this point. Similarly to what was observed in the vertical column, a sharp temperature drop occurred in November 2023, leading to a significant reduction in temperature on the side near the exposed rock surface, persisting until January 2024 and affecting temperatures at all depths. In February, temperatures near the surface experienced a slight rebound. Furthermore, temperatures on the side covered by ice consistently decreased over the five-month period. It is evident that temperatures closer to the West slope are more stable and consistently lower than those on the east (the exposed rock surface).

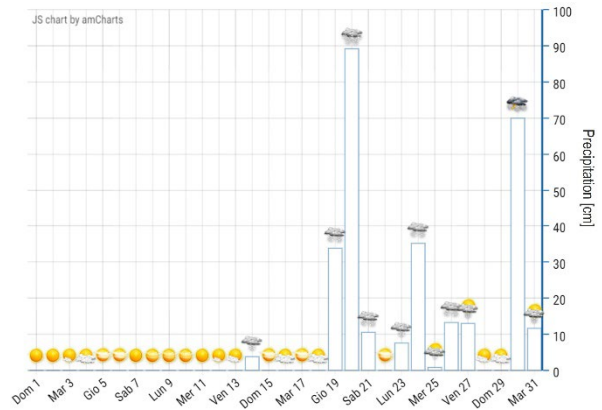
Figure 11 Precipitation in October 2023.

To better illustrate the impact of weather on the temperature of the exposed rock surface, Figure 10 presents temperature recordings taken every half hour in module 7 of the horizontal column. Daily oscillations are quite evident until October 19th, with the maximum temperature typically recorded at 3 p.m. and the minimum one around 9 a.m. However, oscillations became less pronounced and eventually disappeared after October 19th, when a snowfall occurred (Figure 11). Although there is no direct verification, at the moment, it seems reasonable to assume that the snow cover maybe protecting the rock face from direct solar radiation.
