# Impact Of a Low-Income Informal Settlement in a Headwater Area at High-Risk Of Erosion in Brazil

**Abstract** – The largest remaining area of preserved Atlantic Forest in the Belo Horizonte City (Minas Gerais, Brazil) protects many headwaters and watercourses. Among them, the *Macacos* stream is considered the most preserved with high water quality. However, since 2013 this region has suffered an intense and disorderly of informal settlement process by low-income communities, which resulted in a progressive loss of the original vegetation. Due to the lack of vegetation, this area became prone to erosional process as demonstrated by the topographic analysis. The Normalized Difference Vegetation Index (NDVI) demonstrated the great impact of the settlement process over the vegetation, ranging from 1 to 0. Besides, this eroded area has faced the loss of biodiversity as estimated by the richness and Shenon's index as well as the invasion by exotic species as *Brachiaria sp* and *Typha domingensis*. Also, the erosional process in this hilly site resulted in the accumulation of high level of sediments in the Macacos stream. Therefore, the restoration of headwaters and riparian sites ai

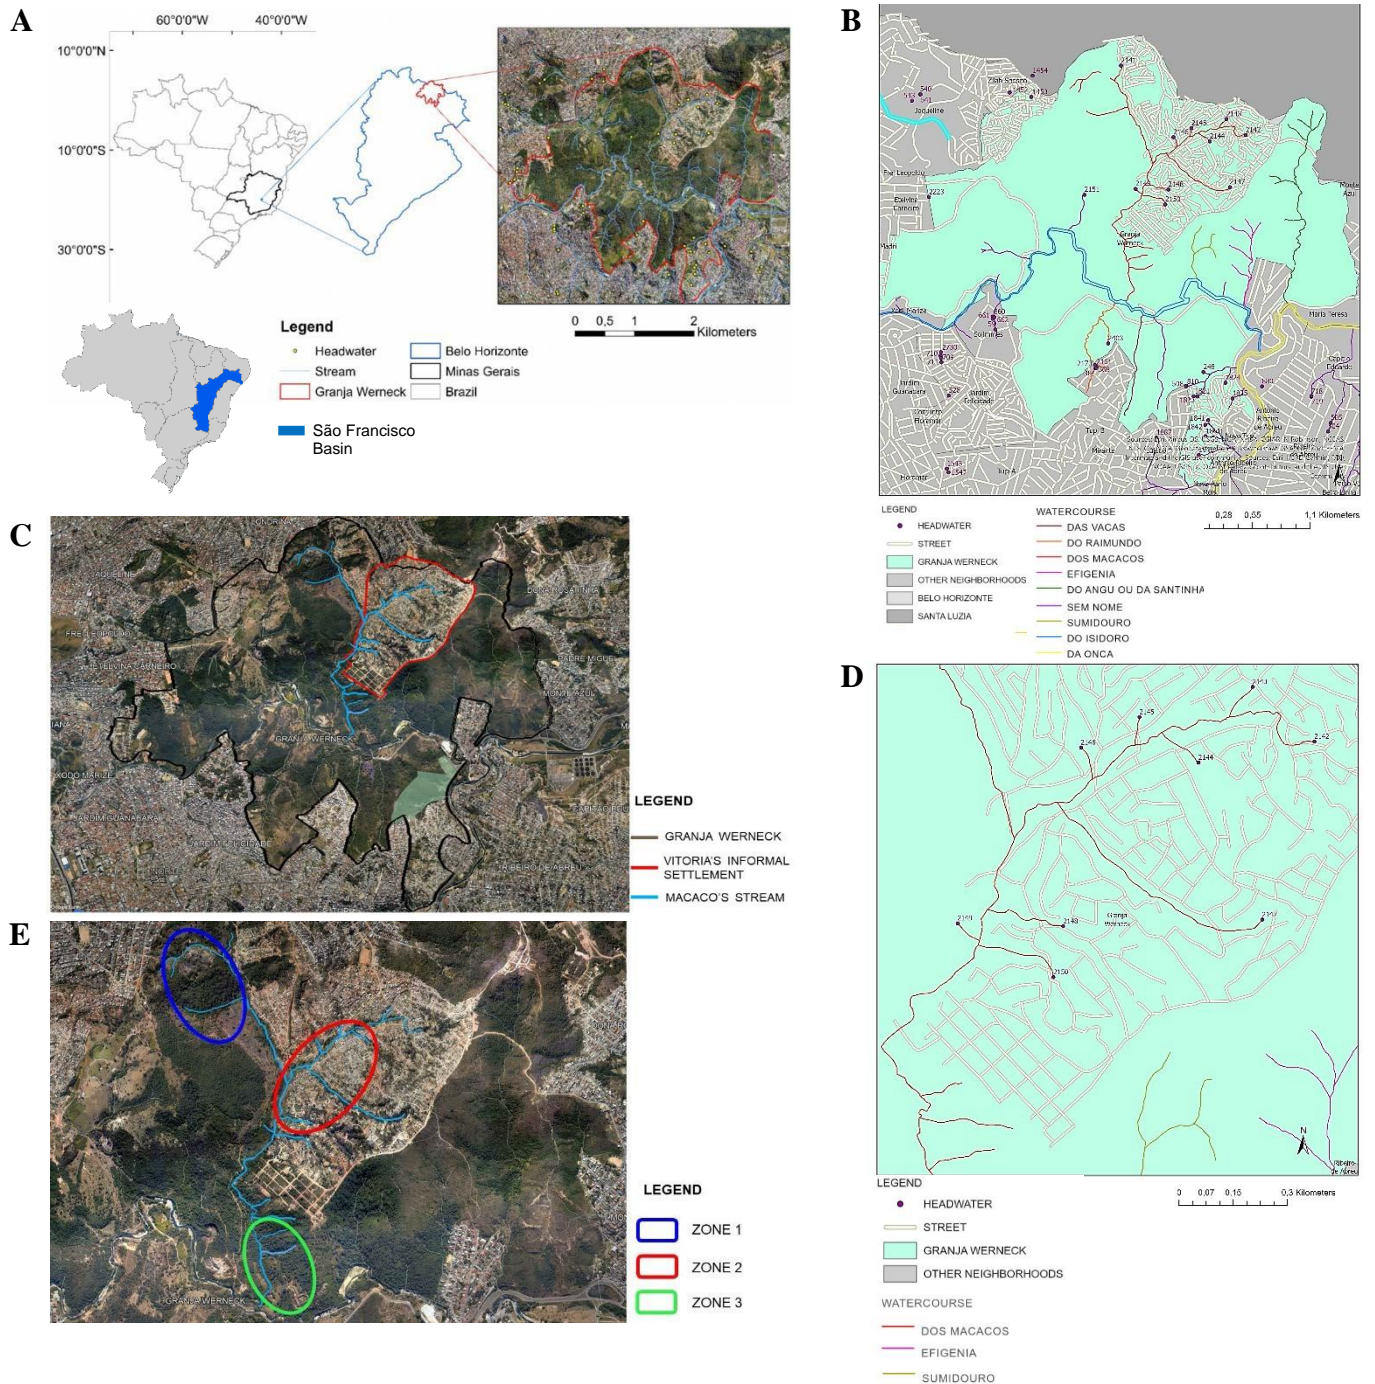
Fig. 1. (A) Location of study area of Isidora micro-basin (Minas Gerais Brazil) made by the authors, modified from Google Earth, 2022. (B) Hydrological map made by the authors, 2022. (C) Victoria's informal settlement in Granja Werneck made by the authors, modified from Google Earth, 2022. (D) Macacos stream and headwaters catalogued by the City of Belo Horizonte Map made by the authors, 2022. (E) Delimitation of the zones of environmental impact made by the authors, modified from Google Earth, 2022.

The study site is located in the north region of the city of Belo Horizonte in the São Francisco's basin (Fig. 1A). This area has been suffering an impact of the disorderly urban informal settlement process, with loss of vegetation and threatening the stability of the soil in the region.

For the floristic analysis, the area was divided into three zones (Fig. 1E) alongside the Macaco stream. The blue zone is characterized by the portion that comprised the majority of the headwaters of the basin but is still subjected to some impact from the urban settlement (Fig. 1E). Zone two (red) refers to the stream fragment along the Vitoria's settlement that is most impacted by the Vitoria's informal settlement. Zone three (green) is the stretch of the Macaco stream which corresponds to a preserved area of Atlantic Forest. The experimental design was composed by three blocks corresponded the three zones mentioned above. Each block was divided in three transects of 30 meters where the plants were sampled. In each transect, it was sampled 3 plots of 5m<sup>2</sup> per plot totalizing 27 samples. All vascular plants, including both in the flowering stage and in the vegetative stage, found inside the plots were sampled according to Braun-Blanquet (1979) [8]. The specimens collected were herborized and deposited at the BHCB herbarium after taxonomic identification.

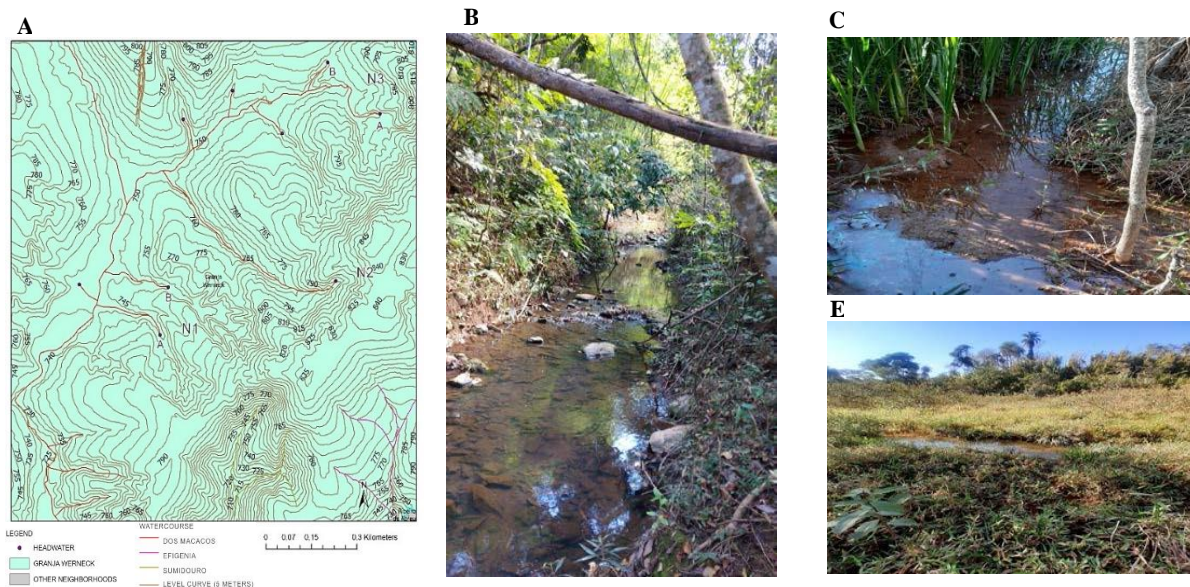
Fig. 2: (A) Topographic analysis of Macacos stream and the study area made by the authors, 2022. (B) Preserved stretch of Macacos stream by by made the authors, 2021. (C) Sediments in Macacos stream made by the authors, 2021. (D) Invasive vegetal species in Macacos Stream made by the authors, 2021.

The Fig. 2A shows that the Vitoria's informal settlement was established on an area at high risk of water erosion, originally composed of several headwaters where the vegetation was completely lost. The altitude difference from 725 to 840 revealed the erosive potential of this area considering the inclination as well as the presence of headwater and streams across the area. Surface water runoff is intensified during rainy season allowing the movement of sediments, further accelerating the erosive process. Although the Macacos stream may be considered still preserved at the zones 1 and 3 (Fig 2 B), the Victoria urbanization has impacted the streams with high level of sediments in zone 2 (Fig. 1E), leading to the massive invasion by exotic species such as *Brachiaria sp* and *Typha domingensis* (Fig. 2 D).

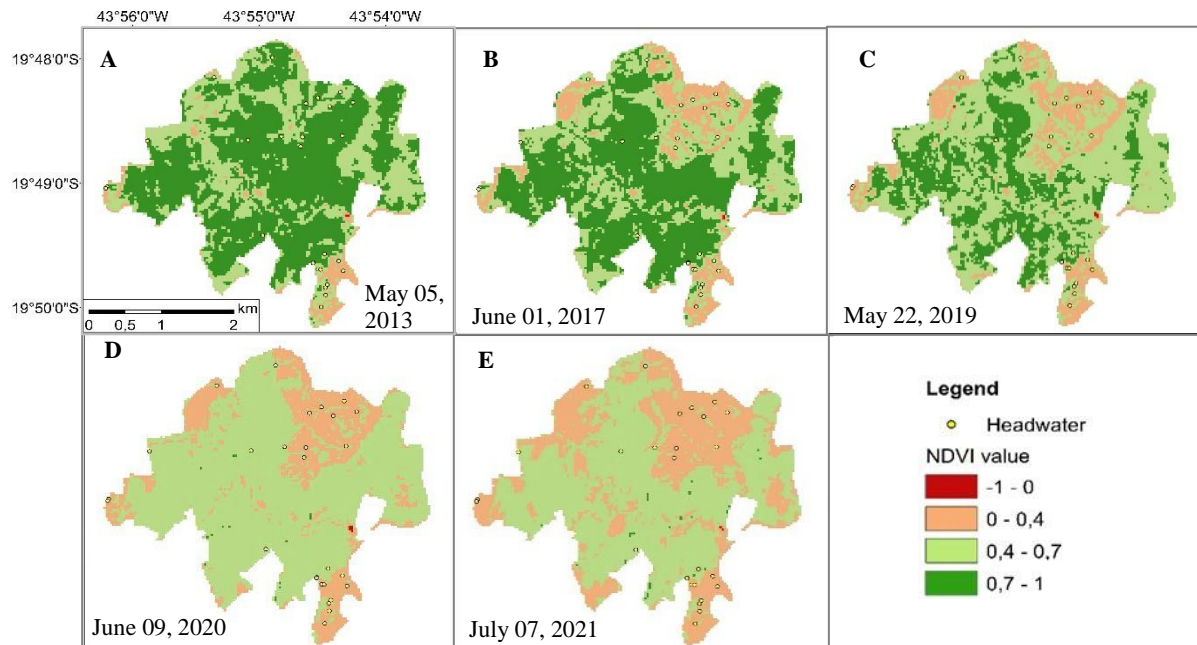
Fig. 3: Normalized Difference Vegetation Index (NDVI) of the Granja Werneck region for the analyzed images obtained in the years (A) 2013, (B) 2017, (C) 2019, (D) 2020 and (E) 2021. Made by the authors 2022.

The satellite images captured until 2013 (Fig. 3A) shows that the land was preserved with a NDVI index around 1. However, after 2013, there occurred a progressive and accelerated loss of vegetation from 2017 to 2019 with a NDVI index of 0.4 (Figs. 3B e 3C). In the last two years (2020 and 2021), the NDVI index drop dramatically, revealing a severe loss of vegetation cover and a serious threat to the several headwaters (Fig. 3D and E). Such vegetation loss was particularly accentuated after 2017 as shown by the NDVI indices, as a consequence of the rapid, intense and disorderly process of urbanization of this area. However, the region surrounding the Victoria urbanization has also suffered an impact on its vegetation structure, especially after 2019 (Fig. 3C), which was attributed to the large contribution of sediments (Fig 2 B) from the collapsing erosions.

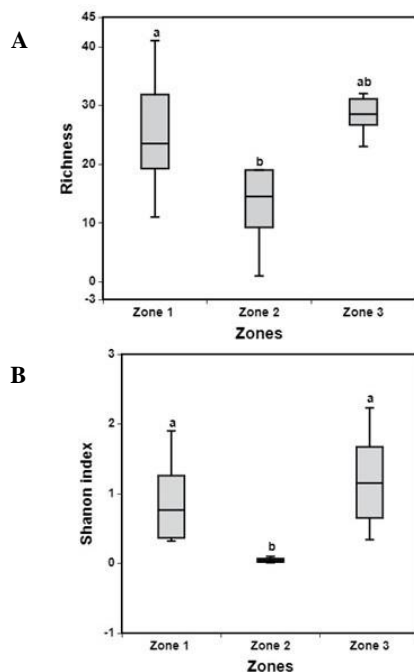
Figure 4 - Comparison of richness (A) and Shannon's diversity index (B) of species found in 3 studied zones 1, 2 and 3: Analysis of variance were performed using Anova and Multivariate comparisons were performed using Tukey's test at significative level of  $p \leq 5\%$ .
