First Results of the Application of Infrared Thermography to the Crack Inspection in Wooden Beams

Miguel Gallego¹, Manuel Cabaleiro¹, Ivan Garrido², Borja Conde¹, Belen Riveiro¹

¹Department of Materials Engineering, Applied Mechanics and Construction, University of Vigo,
C.P. 36208, Vigo, Spain

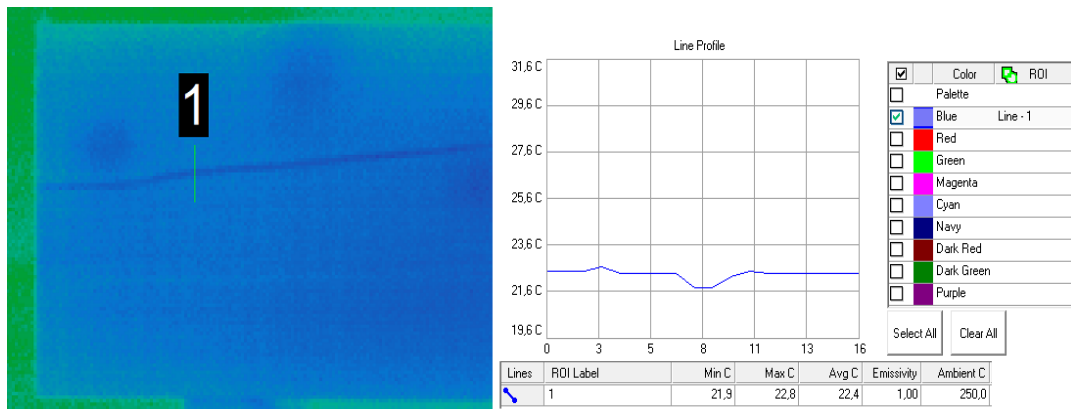
Fig. 3: Example of temperature variation (°C) crossing a crack (its width).

In the first methodology, a total of 7 cracks are analysed, 3 for the pine beam (Beam 1) and 4 for the oak beam (Beam 2). As it can be seen in Figure 2, the cracks are clearly visible in the thermal images due to the existence of a thermal difference between these defects and the unaltered surroundings of the beams. Figure 3 shows a straight line crossing one of the cracks of Beam 1 on the thermal image acquired with the help of the Image Processor Pro II © (called ‘Line - 1’), and a graph of how varies the temperature value along the pixels of the ‘Line-1’.

Table 1 compares the width measured in the thermal image with the real width measured manually for each crack (specifically cracks 1 and 2 (Beam 1), 6 and 7 (Beam 2)). This is done by counting the number of pixels of the straight line crossed in each crack on the thermal image and then multiplying by its equivalency (‘distance/pixel’ ratio) to estimate the width in metric units. The equivalency is obtained since the real width of each beam is previously known. In this case, the equivalency is 1.67 mm/pixel for both Beam 1 and Beam 2.

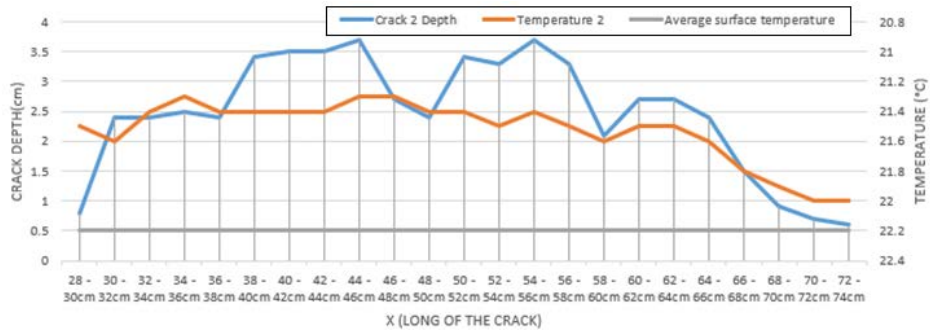
Fig. 4: Crack 2 of Beam 1: Variation of depth versus the temperature variation.

Moreover, **Figure 4** illustrates the variation of depth in Crack 2 (Beam 1) versus the temperature value in each 2 cm section along the long of the Crack 2 (taking the lowest temperature in each section). In addition, in **Figure 5** it is shown the width variation of Crack 2 versus the temperature value in the same sections used in **Figure 4**.

Figures 4 and 5 are modified by reversing the ordinate axis of the temperature. This is to clearly see the correlation between the increase of the depth/width/cross section of the crack and the decrease of temperature. Thus, as the depth/width/cross section of the crack increases, so does the temperature in the figures.

Therefore, it can be concluded that it is possible to measure the long and width of a crack and not its depth with the proposal of this first method. It should be noted that, in order to better understand the results, the average surface temperature at the time of the measurements is also shown from Figure 4 to Figure 6, where it can be seen that the average surface temperature of the beams is always lower than the temperature of the cracks.

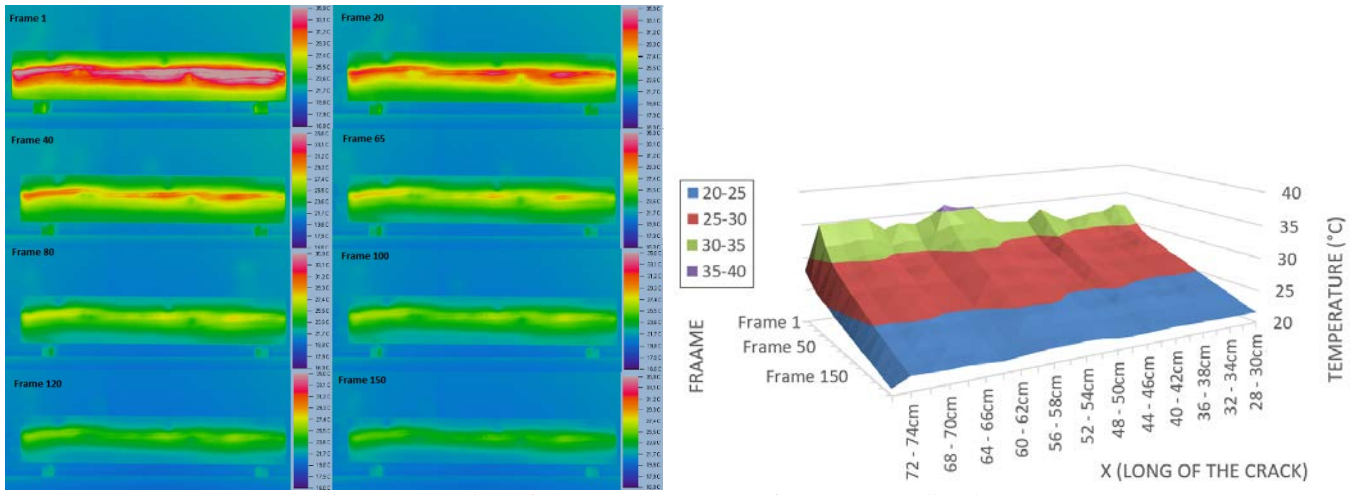
Fig. 7: a) Cooling of Beam 1. b) Crack 2 of Beam 1. Cooling in 3D.

As for the second methodology, Figure 7.a presents a sequence of thermal images of the cooling process of Beam 1. In Figure 7.b, a 3D graph of the cooling process of Crack 2 of Beam 1 is shown.

As can be seen in Figure 7, during the first frames there is a high difference between the temperature in the cracks and the unaltered surroundings. From frame 80, the temperatures start to be similar and it is more complex to distinguish the presence of the cracks. The frames in which the cracks are more visible are from frame 20 to frame 40. In that time interval (frame 20 to frame 40), the surface of the beam stops dissipating heat except in the cracks, thus being the areas of the defects sharper. Similar thermal behaviour occurs in Beam 2 during the cooling process, with the interval of the frames in which the cracks are most clearly visible the same as in Beam 1.
