Experimental Study on Shear Performance of Poplar LVL Beams with Opening in Bending-Shear Region

Abstract - To investigate the shear performance of Italian poplar laminated veneer lumber (LVL) beams with opening in the bending-shear region, six standard specimens were designed and tested under four-point bending. The shear failure mechanisms of the LVL beams with opening under various parameters were analyzed. The results show that the unperforated beam experiences bending failure due to tensile cracking at the mid-span. In contrast, beams with circular opening experience longitudinal shear failure at the ends due to stress concentration around the opening perimeter. The maximum transverse tensile strain around the opening perimeter forms an angle of approximately 45° or 225° relative to the longitudinal axis of beam, consistent with the crack initiation angle. As the diameter-to-height ratio increases to 0.5, both cracking and ultimate load capacities of the beams with circular opening significantly decrease, exhibiting more brittle shear failure. When the diameter-to-height ratio increases from 0.3 to 0.4 and 0.5, the ratio of cracking to ultimate load capacity increases from 0.

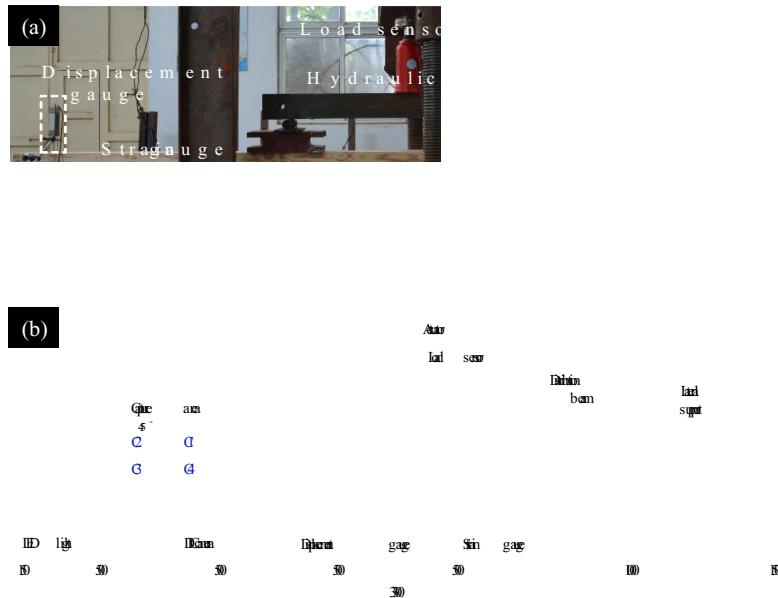
Fig. 2: Layout of test loading device and measuring points (unit: mm): (a) actual photograph; (b) schematic diagram.

The four-point bending tests on the timber beams were conducted. The loading setup and sensor arrangement are illustrated in Figure 2. A preloading step was first applied to the timber beams. After confirming the proper functioning of the instrumentation, the beams were unloaded to their original state. Formal loading was performed using a displacement-controlled mode, with an initial loading rate of 2 mm/min. When cracking occurred in the timber beams, the loading rate was reduced to 1.5 mm/min until complete failure of the specimens. To measure the vertical deformation of the timber beams during loading, five displacement transducers were arranged at the loading points, supports, and mid-span of the specimen. To measure the principal strain around the hole, four strain gauges (labeled C1 to C4) were arranged counterclockwise along the edge of the hole. All load, displacement, and strain data were measured and recorded using the TDS 530 data acquisition system. The Digital Image Correlation Method (DICM) was employed to quantitatively analyze the vertical strain field around the openings.

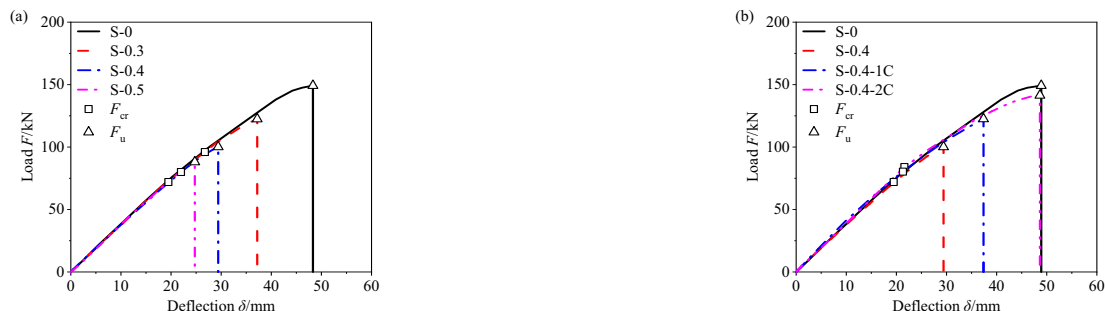
Fig. 6: Load-deflection curves: (a) effect of diameter-to-depth ratio; (b) effect of the number of layers of circumferential CFRP wrap.

Figure 6 shows the load-deflection (F - δ) curves for all specimens, while Table 3 provides the experimental results for each specimen. Where, F_{cr} refers to the cracking load, representing the load on poplar LVL beams when the first major crack appears at the upper-right or lower-left edge of the hole. F_u is the ultimate load at which the poplar LVL beam fails. δ_{cr} and δ_u are the deflection at midspan when cracking occurs and the ultimate deflection at failure, respectively.

As shown in Figure 6 and Table 3, prior to reaching the ultimate load, all specimens exhibited load-deflection curves without distinct yield points, demonstrating typical brittle failure characteristics. The load-deflection curve of the non-perforated beam specimen S-0 displayed the most pronounced nonlinearity, along with the highest ultimate load and deflection. As the diameter-to-height ratio increased, the ultimate load and deflection of perforated beam specimens S-0.3, S-0.4, and S-0.5 decreased sequentially. This is attributed to the fact that openings in the bending-shear region promote longitudinal cracks parallel to the beam axis, leading to stress concentration at crack tips and reduced deformation compatibility in the adjacent wood, thereby diminishing the load-bearing capacity and deflection of unreinforced perforated specimens. Compared to the non-perforated control specimen S-0, the ultimate loads of specimens S-0.3, S-0.4, and S-0.5

decreased by 17.9%, 32.9%, and 40.9%, respectively, with corresponding reductions in ultimate deflection of 23.0%, 39.1%, and 48.8%. Furthermore, the failure modes of specimens S-0.3, S-0.4, and S-0.5 shifted to longitudinal shear failure at the beam ends. When the diameter-to-depth ratio increased from 0.3 to 0.4 and 0.5, the ratio of cracking load to ultimate load for perforated beams rose from 0.79 to 0.80 and 0.81, respectively. These results indicate that openings in the bending-shear region alter the failure mode of timber beams, with the diameter-to-depth ratio being a critical factor governing their mechanical performance. As the diameter-to-height ratio increases, perforated beams exhibit more pronounced brittle characteristics during shear failure.

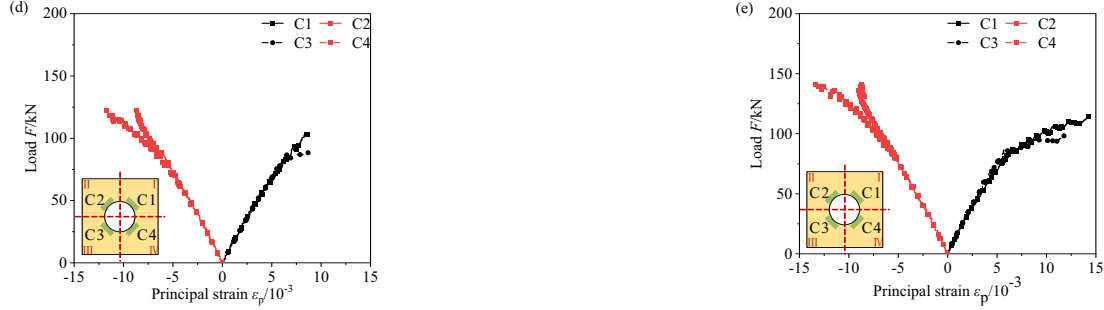
Fig. 7: Load- principal strains: (a) S-0.3; (b) S-0.4; (c) S-0.5; (d) S-0.4-1C; (e) S-0.4-2C.

Figure 7 presents the load- principal strain (F - ε_p) curves for all specimens. Where the rectangular region around the hole is divided into four quadrants (quadrants I ~ IV). The experimental results show that the principal tensile strains around the hole are primarily distributed in quadrants I and III, while the principal compressive strains are concentrated in quadrants II and IV. This aligns with the observed test results, where the hole's shape changes from circular in the unloaded state to elliptical at final failure. For specimens S-0.3, S-0.4, and S-0.5, the load-hole's periphery principal strain relationship appears approximately linear, with a reduction in the slope as the diameter-to-height ratio increases. This reduction is mainly due to the stress concentration around the hole, which weakens the poplar LVL's stiffness. After circumferential CFRP wrap around the hole, the load-hole's periphery principal strain curves for specimens S-0.4-1C and S-0.4-2C exhibit some nonlinearity. This suggests that circumferential CFRP wrap contributes to shear resistance and helps distribute the stress at the ends of cracks, reducing the impact of stress concentration. The principal tensile and compressive strains around the hole in reinforced beam specimens are greater than those in unreinforced beam specimens, which is likely due to the greater deformation occurring in the reinforced beams during loading.
