Remediation Activities in an Italian Superfund: Case Study of an Industrial Plant in Broni

Abstract – The Italian Ministry for the Environment and Protection of the Land and Sea (MATTM) has identified through Ministry Decree n. 468/2001 and its integrations, 40 Italian Superfund within the national borders, 10 of which are contaminated mainly by Asbestos. Within these areas, the INAIL-DIT play a role in finding and managing issues related to Asbestos and Asbestos Containing Materials (ACMs), together with others national institutes. This activity is made by an “ad hoc” working group, with the aim to identify the best Emergency Safety Measures, or remediate these sites, together with occupational and population risks monitoring and prevention, and to ensure the best available technologies. In this paper a very complex site has been described; we explain the remediation project designed after the prescriptions made by the INAIL-DIT experts in order to reduce the contamination in the working area and the living environment.

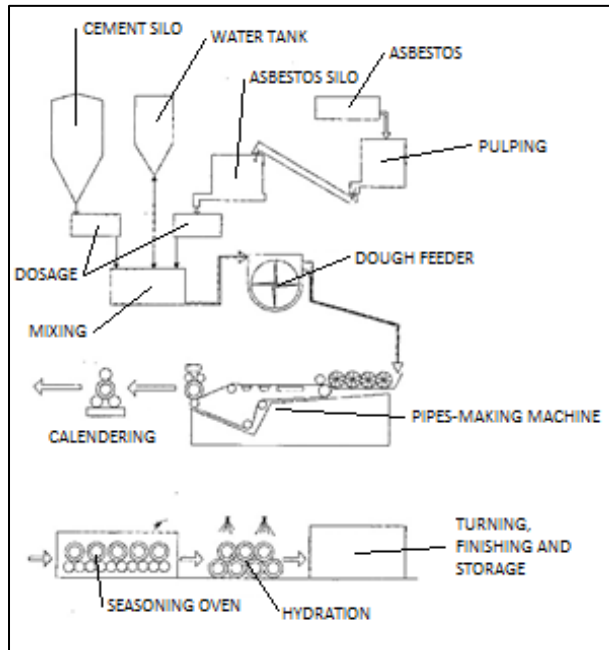
Fig. 2: Pipe's production process.

The process consisted of the following steps: 1) Material discharge, 2) Mix of various asbestos variety, 3) Mixture preparation, 4) Products shaping, 5) Maturation, 6) Finishing, 7) Final storage. The Fig. 2 shows the pipe's production process, while the Fig. 3 outlines the production of corrugated sheets.

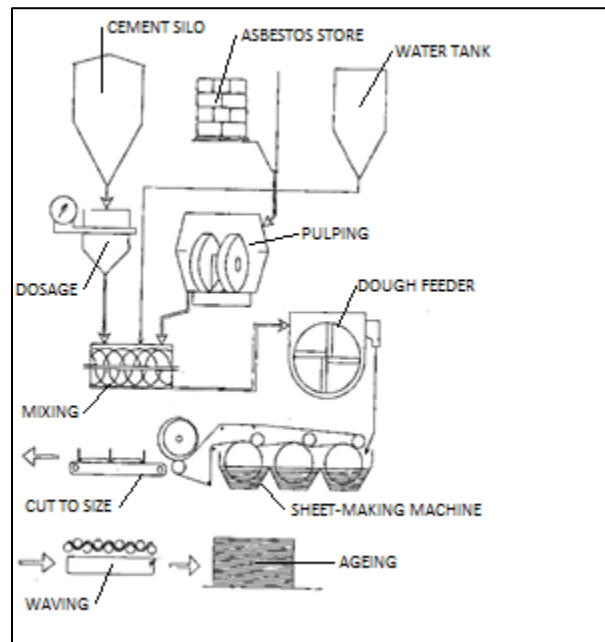
Fig. 3: Corrugated sheet's production process.

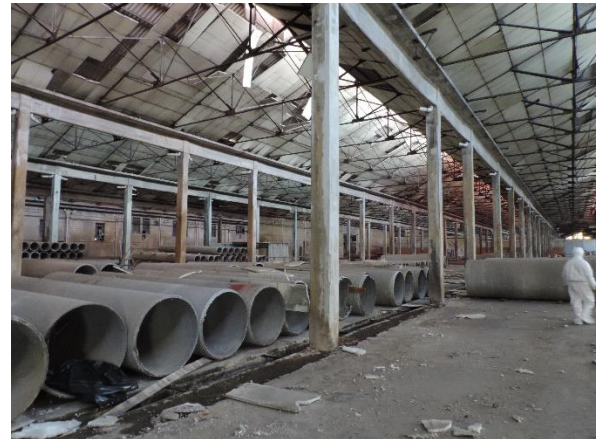
Fig. 4: Map and image of the Broni Fibronit Superfund.

After identification by the Ministry for the Environment and Protection of the Land and Sea (MATTM) through Ministerial Decree n. 26 November 2002 and Italian Law n. 179/2002 [4], at present time the site's property is divided by three: the Fibroservice area, the ex-Fibronit area and the ex-Ecored area. Within the last two areas some Emergency Security Measures have been carried out, due to the high potential of pollution spread. In the ex-Fibronit area, all the outdoor Asbestos Containing Waste (ACW) have been encapsulated, packed up and sent for disposal to licensed off-site landfills. All the waste produced during pipes production have been removed from the ex-Ecored uncovered area, which extends for about 450 m², together with the mud accumulated along the meteoric water channels. In the ex-Fibroservice area, the square has been cleaned up and all the asbestos-cement coverings have been removed. The encapsulation of the asbestos-cement sheets (which formed the cover and the side buffering of the sheds) and the sealing of the openings constituted the Emergency Safety Measures. The Superfund has been divided into remediation lots, as follows (see Fig. 4): the shed B into B1- B6 lots, while shed C into C1 and C2 lots.
